THE CRANE CORNER

Jun 2019
102nd Edition

Navy Crane Center Technical Bulletin

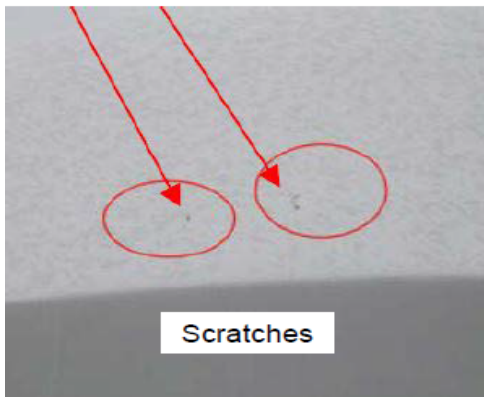
A load contacted a ship's radar dome, causing what appeared to be, minor, easily overlooked damage (see photo). Upon recognizing the contact, the crane crew stopped operations and reported the event. Initial notification mentioned minor paint damage; however, further investigation identified that internal components were damaged and the dome required replacement. This raised the status of this "minor" contact (scratch) accident to a "significant" accident due to the very high cost of radar dome replacement.

The consequences of a ship deploying with a critical system, such as a radar dome, being less than 100 percent is not an option.
