# THE CRANE CORNER

Dec 2019  
104th Edition

## *Navy Crane Center Technical Bulletin*

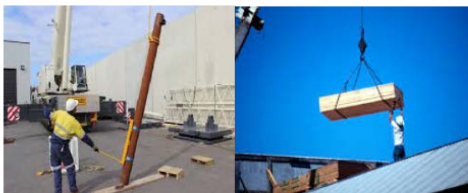
**DO NOT work under the load or stand in the fall zone as shown above!**
