THE CRANE CORNER

Mar 2020
105th Edition

Navy Crane Center Technical Bulletin

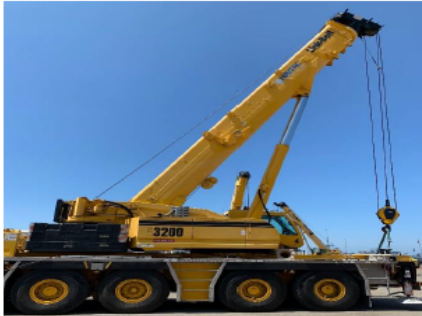
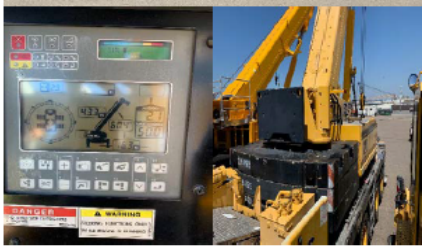
Title: Mobile Crane Near Miss
Target Audience: Weight Handling Program and Crane Oversight Personnel

While making preparations **for a complex lift of personnel** in a basket, the crane supervisor was contacted prior to the lift in order to review and provide oversight of the dry run in accordance with NAVFAC P-307, paragraph 10.4.1.2. Upon arrival on-site, the supervisor identified that the crane was set-up without the counterweight. The operator assumed that the counterweight was raised based on the on-screen computer display and belief that the crane team had completed a visual inspection of the counterweight being in the up position. The supervisor immediately secured the operation due to the **potential for crane overload or overturning the crane**. The activity's investigation identified the following:
