THE CRANE CORNER

Jun 2020
106th Edition

Navy Crane Center Technical Bulletin

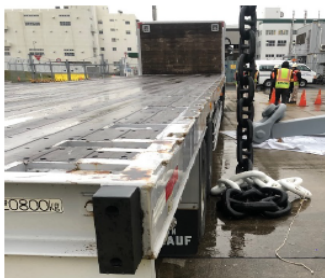
- **The end of an anchor chain fell from the bed of a trailer during removal.** Personnel did not account for how close the chain was to the edge of the trailer or the movement caused during hoisting due to chain length (inadequate risk mitigation). A photo of the dropped anchor chain is shown.

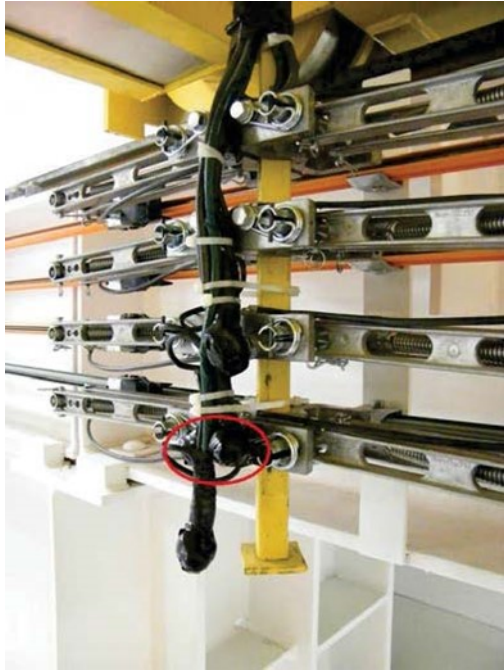
Collector Assembly

One final area of concern reported to Navy Crane Center by activities experiencing problems is collector shoe leads and other connections not secured in an enclosure. As these are parts of a moving system, particular care must be taken to ensure that these connections are appropriately insulated and secured to protect the insulation from mechanical damage.

In conclusion, all Navy weight handling equipment wiring connections not landed at a terminal strip must have care taken that they are properly insulated in accordance with the guidance and requirements of the NEC and NAVCRANECEN 11450.2A. Additionally, these connections shall be inspected and maintained in accordance with the requirements of the NAVFAC P-307 Weight Handling Program Management to ensure that the insulation retains its integrity and the connections remain tight over the life of the crane.

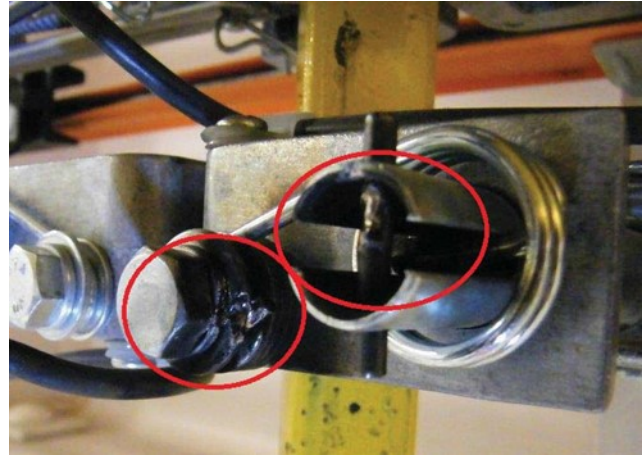
Contact Points

One down side to taping a connection is that this method can result in a very bulky connection, and in some cases, the bulkiness of this method results in a higher likelihood of mechanical wear within a particularly tight motor or brake connection box. It is for these cases that the latest revision of the NAVCRANECENINST 11450.2A allowed for "pre-insulated compression splice connectors." Switching to this type of connection has a downside for future maintenance because they are very difficult to remove without cutting the conductors, resulting in shortened motor or brake leads. Another alternative is the "identified insulating device" allowed for in NEC paragraph 110.14(B) which may not be any less bulky, but may be less prone to mechanical damage.
