THE CRANE CORNER

Mar 2021
109th Edition

Navy Crane Center Technical Bulletin

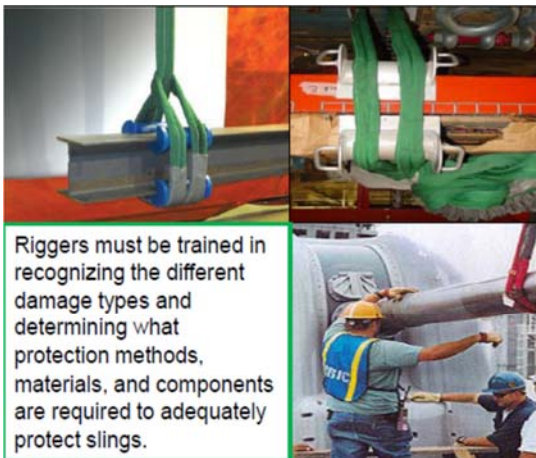
Title: The “ABCs” of Sling Protection
Target Audience: Weight Handling Program Personnel

> **Abrasion:** Can occur when the sling is in contact with rough surfaces, such as concrete pipe. The sling protection shall be suitable to accept the abrasion without being destroyed.

> **Bearing:** As the sling contact width decreases, the pressure increases and sling protection material may be severed. When required (e.g., small diameter pin with multiple highly loaded slings), the calculation for determining a sling protection’s resistance to bearing failure shall be obtained from the sling OEM and varies according to the material, radius, and pressure.

> **Cutting:** Slings wrapped around corners and edges have the potential to fail. This is the primary cause of reported synthetic sling failures. Soft protective materials (canvas, fire hose, leather straps/gloves) do not ensure adequate protection from cutting and shall not be used. The sling must be completely blocked from contacting the load edge with a hard material, such as split piping sections or special rounded shoes (see illustrations). Sling OEMs also provide products that protect slings from sharp corners or edges. Activities should contact the OEM for availability of such products.

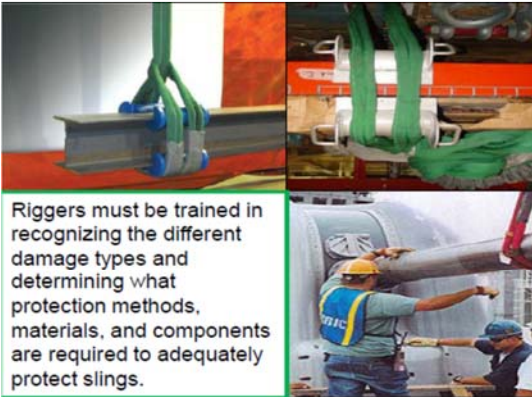
Title: The "ABCs" of Sling Protection
Target Audience: Weight Handling Program Personnel

➤ **Abrasion:** Can occur when the sling is in contact with rough surfaces, such as concrete pipe. The sling protection shall be suitable to accept the abrasion without being destroyed.

➤ **Bearing:** As the sling contact width decreases, the pressure increases and sling protection material may be severed. When required (e.g., small diameter pin with multiple highly loaded slings), the calculation for determining a sling protection's resistance to bearing failure shall be obtained from the sling OEM and varies according to the material, radius, and pressure.

➤ **Cutting:** Slings wrapped around corners and edges have the potential to fail. This is the primary cause of reported synthetic sling failures. Soft protective materials (canvas, fire hose, leather straps/gloves) do not ensure adequate protection from cutting and shall not be used. The sling must be completely blocked from contacting the load edge with a hard material, such as split piping sections or special rounded shoes (see illustrations). Sling OEMs also provide products that protect slings from sharp corners or edges. Activities should contact the OEM for availability of such products.

Riggers must be trained in recognizing the different damage types and determining what protection methods, materials, and components are required to adequately protect slings.

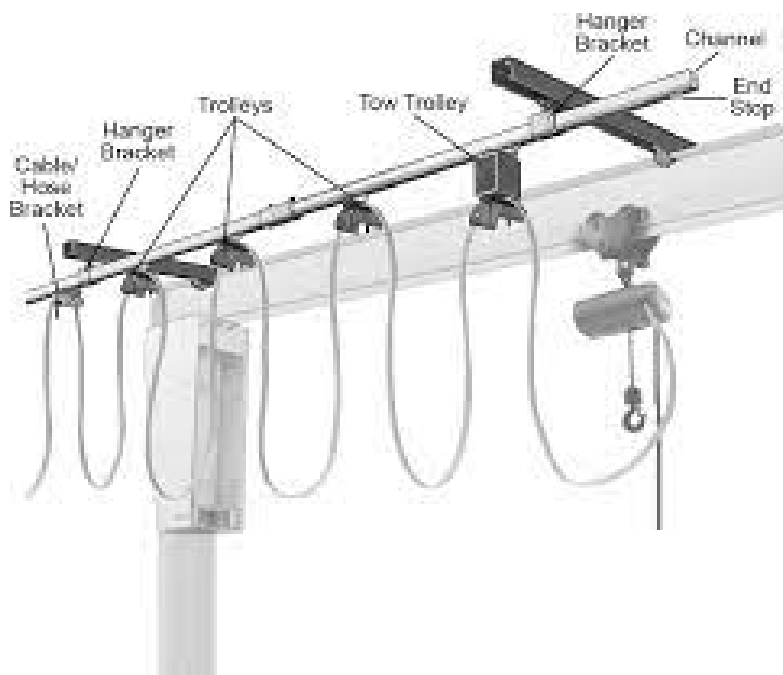
Festoon hardware consist of several components that support the power and control cables for safe and reliable operation of the crane. Care is required during initial installation and subsequent maintenance and adjustment to ensure that damage does not result during operation. Hardware components may include the tow trolley, tow bar, cable trolley, tow webbing, and shock cord assembly. These components reduce stress on the festoon power and control conductors or cable.

- The tow trolley provides an area to interface with the tow bar. The tow bar, fixed to the crane, engages the tow box to move the festoon system. The tow bar should be centered top to bottom in tow box that allows the crane or hoist to move up and down and not cause any damage.
- The cable trolley (support saddle) is the device that carries the festoon cable down the track. Flat cable arrangements should be such that larger conductor size cables (power cables) are on top of the stack when placed on the support saddle, which provides a large bend radius for the larger power cables. With a combination of flat and round cables, place large round cables on the outer most positions of the cable saddle.

- The tow webbing is for both high speed and outdoor applications to reduce the shock and pulling tension on the electrical cable. Tow webbing is not necessary on all systems. The tow webbing is installed on top of the electrical cable and is held in place with the saddle on the cable trolley. The tow webbing for the power side of the festoon system webbing is three inches less in length than cables per loop.
- The shock cord assemblies are shorter than tow cables, are used in pairs, and are spring loaded acting as shock absorbers to limit undue stress when the festoon trolley begins to move.

After performing maintenance or repair, it is important to ensure festoon hardware is re-attached correctly. This includes, but is not limited to, ensuring festoon cable loops do not extend low enough to come into contact with obstructions, cable is properly secured to not allow excess movement of components, all fasteners are properly secured, festoon cables are arranged free of twist, and suitable strain relief is provided/maintained.
