THE CRANE CORNER

Mar 2022
113th Edition

Navy Crane Center Technical Bulletin

CSA 243 – RECALL OF CROSBY GROUP 1-INCH SCREW-PIN SHACKLES

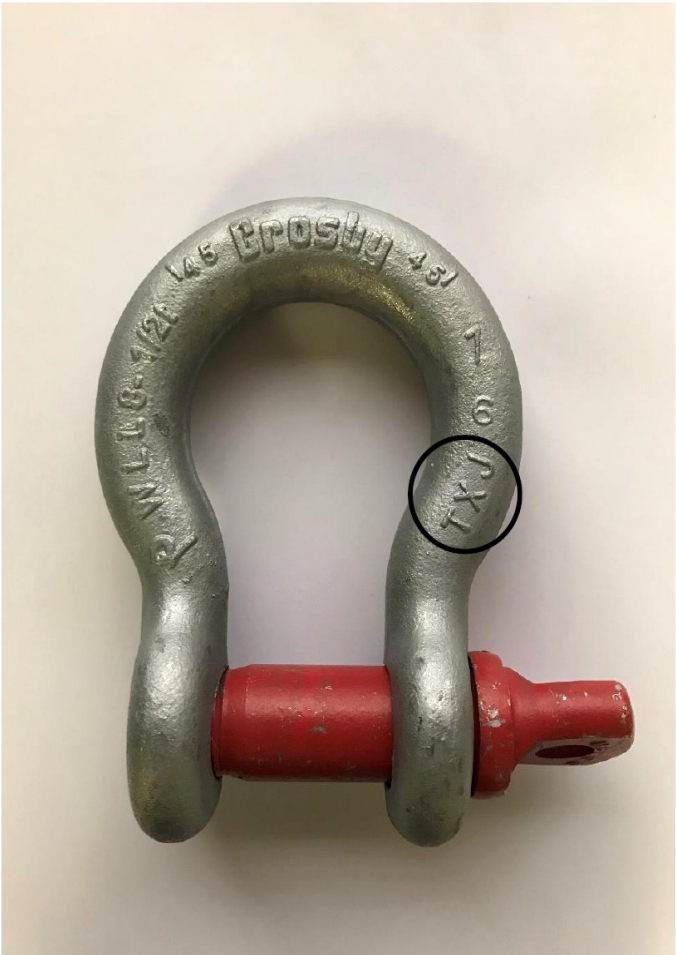
Production Information Code (PIC) Location

THE CROSBY GROUP has determined the above listed screw pin anchor shackles may have a condition that can reduce the ultimate load capacity from the published catalog values. The shackle bow may have a previously undetected indication, and continued use may result in loss of load, property damage, severe injury, or death.

By use of the Production Identification Code (PIC) symbols appearing on the product, we have determined the 1" 8.5t screw pin anchor shackles with PIC TXJ shown on the bow may have this condition. See below image showing the position of the PIC on the bow. No other sizes or PICs are part of this Important Safety Notice. The potentially impacted products were shipped from Crosby between November 23, 2021, and January 28, 2022.

In the event you do have any 1" 8.5t shackles with PIC TXJ, we request you to remove them from service, and arrange for return and replacement. To return these products, please contact your Crosby Distributor. For more information concerning this Important Safety Notice, contact Technical Support at 1-800-220-8509 or crosbytechsupport@thecrosbygroup.com.
