# THE CRANE CORNER

## *Navy Crane Center Technical Bulletin*

67th Edition – September 2010

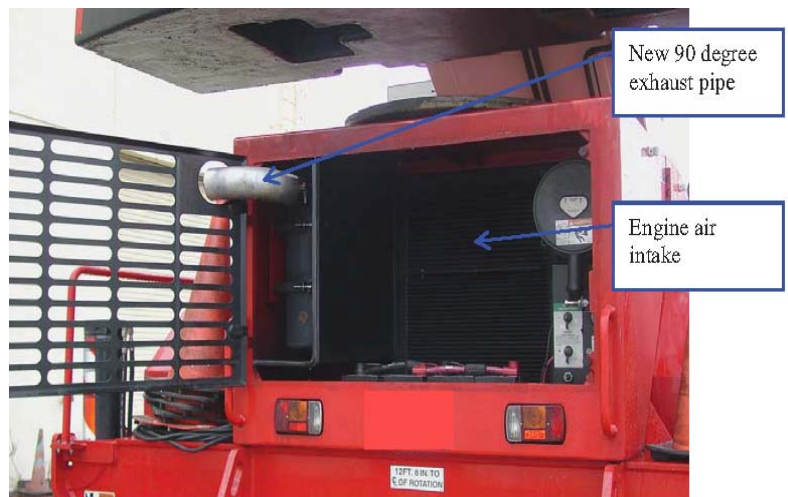
A Navy shore activity was replacing intake filters on several mobile cranes every 150 hours – an unusually frequent rate. Investigation determined the likely cause to be the wind blowing engine exhaust into the air intake. The activity personnel did not accept the prospect of instituting an operational limitation or accepting the higher maintenance costs. They changed the orientation of the exhaust by replacing the straight exhaust pipe with a 90 degree pipe. A terrific low-cost solution to the problem!

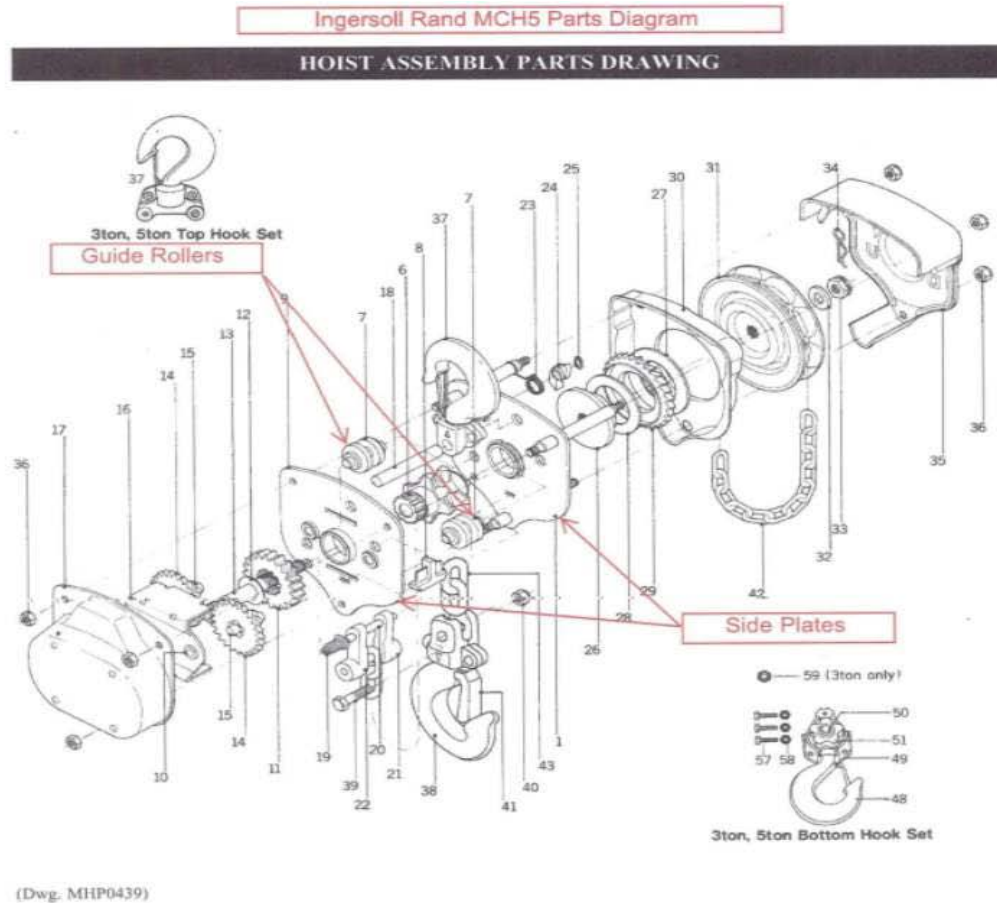
**CSA 193  
Attachment (1)**

B. There have been additional incidents involving 3 and 6-ton Ingersoll Rand MCH5 manual chain hoists where the guide rollers were dislodged allowing the load chain to disengage from the load sprocket causing a loss of load control. The investigation concluded that a twist or kink in the load chain may have jammed into the guide roller causing it to dislodge and allowing the load chain to become disengaged from the load sprocket. All of the hoists involved showed signs of spreading of the side plates that retain the guide rollers. The guide rollers are more prone to dislodge if the side plates are spread from their normal position (see Ingersoll Rand MCH5 parts diagram below). Subsequent inspection of additional Ingersoll Rand chain hoists found similar signs of spread side plates. This type of side plate construction and guide roller design may also be common on other chain hoists manufactured by different OEM's.

C. It is imperative that users and maintenance personnel pay close attention to the condition of chain hoists at pre-use inspections, during use, and at maintenance inspections. During pre-use inspections, personnel shall pay attention to the condition of the hoist in the area of the load chain sprocket and guide rollers. Chain hoists showing signs of spread side plates or questionable fitting guide rollers shall not be used. After transporting chain hoists, the load chain shall be freely suspended and carefully checked to ensure that the load block has not flipped through the chain falls and that the load chain is not twisted or kinked (including the dead-end portion of load chain). During use, check to ensure that slack load chain does not become twisted or kinked and that the load chain is feeding properly into the guide rollers. Extra caution shall be used when operating near the hoists upper limit of travel to avoid two blocking or contact with the hoist side plates. During maintenance inspections, load chains shall be lubricated as recommended by the OEM. The load chain shall be carefully inspected and chain stretch and wear measurements taken to ensure the chain is within acceptable limits. This ensures proper operation over load sprockets and chain sheaves.

A. Activities shall inspect all Ingersoll Rand manual chain hoists for evidence of spreading of side plates and for proper engagement of the guide rollers within 30 days of issuance of this CSA. Suspect hoists shall be removed from service for evaluation and/or repair/replacement.

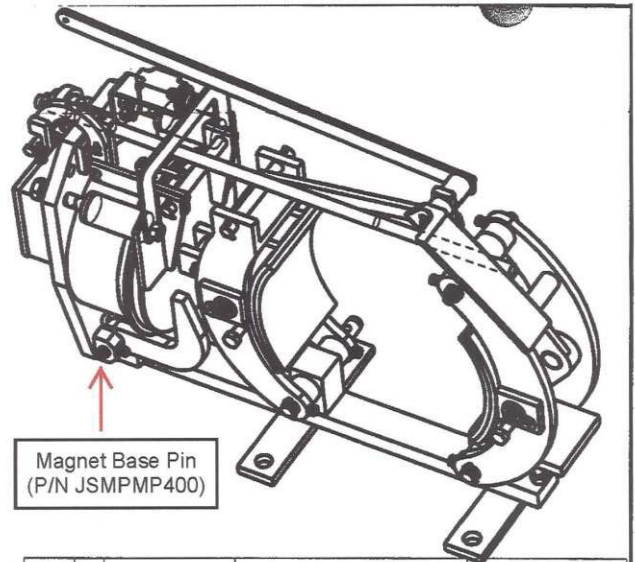
JOHNSON INDUSTRIES SMAA 16 DRUM BRAKE MAGNET BASE PIN  
LOCATION

A. The purpose of the CSA is to alert activities of the failure of the magnet base pivot pin (part number JSMPMP400) on the Johnson Industries SMAA 16 drum brake as shown on Johnson Industries SMAA 16 Drum Brake Magnet Base Pivot Pin Location drawing. An activity servicing a hoist brake removed the brake coil for replacement. The magnet base pivot pin broke during brake reassembly. Laboratory analysis concluded the pin failed due to fatigue. Laboratory analysis also concluded the fatigue cracks most likely started inside the pin along a lubrication port where a crack cannot be easily detected by visual or other inspection methods. Johnson Industries has confirmed that the pin material is Type 303 stainless steel.

B. Johnson Industries has evaluated the pivot pin design and has recommended replacing pins having lubrication ports, and that have been subjected to over 225,000 brake cycles. Johnson Industries also recommends future replacement of pivot pins with non-lubricated (solid) pins.

A. Activities shall immediately remove from service all hoists with Johnson Industries SMAA 16 drum brakes that have magnet base pivot pins with lubrication ports (part number JSMPMP400), and that have been subjected to over 225,000 cycles of operation. Hoists with SMAA 16 brakes where the number of brake cycles cannot be determined and the magnet base pivot pin has a lubrication port shall also be removed from service.

B. Activities shall install new magnet base pivot pins on hoist brakes removed from service identified above prior to returning the hoist to service. Replacement of pivot pins with like replacements (pins with lubrication port) is acceptable for near term corrective action.

C. For long term corrective action, activities shall install new non-lubricated (solid) pins for all hoists using SMAA 16 brakes before or during the next scheduled annual or type B inspection or if the brake is subjected to over 225,000 cycles, whichever comes first. Submit a CAR for NAVCRANECEN approval for replacing the magnet base pivot pins with non-lubricating (solid) pins.

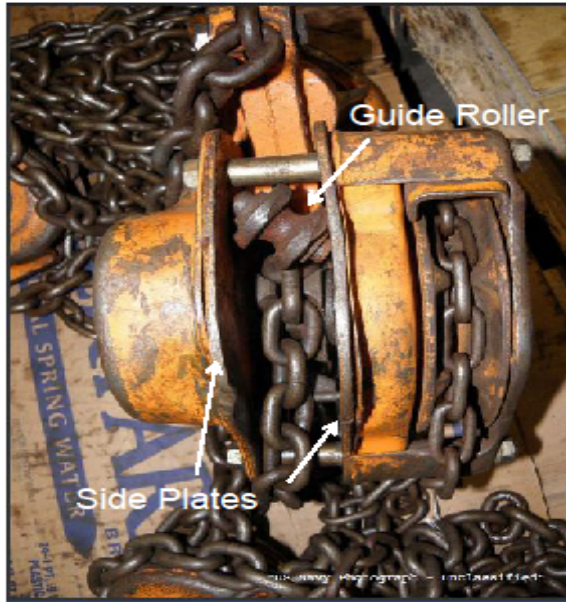
Title: CHAINFALL GUIDE ROLLER PRECAUTIONS

- Several manual chainfall users have experienced rigging gear accidents when the load chain guide roller became dislodged as a result of **improper use or inadequate maintenance / inspection**. In some cases chainfalls have been inspected, tested, and returned to service with the guide roller dislodged. Misuse included two-blocking, side loading and "bunching" of load chain.

- Users of manual chainfalls should ensure guide rollers are in good working order and chainfalls are properly oriented during load movement. Always follow the appropriate manufacturer guidelines and training requirements for use.

- During the pre-use inspection, inspect chainfall side plates for spreading, the guide roller for correct orientation and verify guide roller turns freely by hand. Ensure that the load chain is properly lubricated per the OEM requirements.
