THE CRANE CORNER

Navy Crane Center Technical Bulletin

70th Edition – June 2011

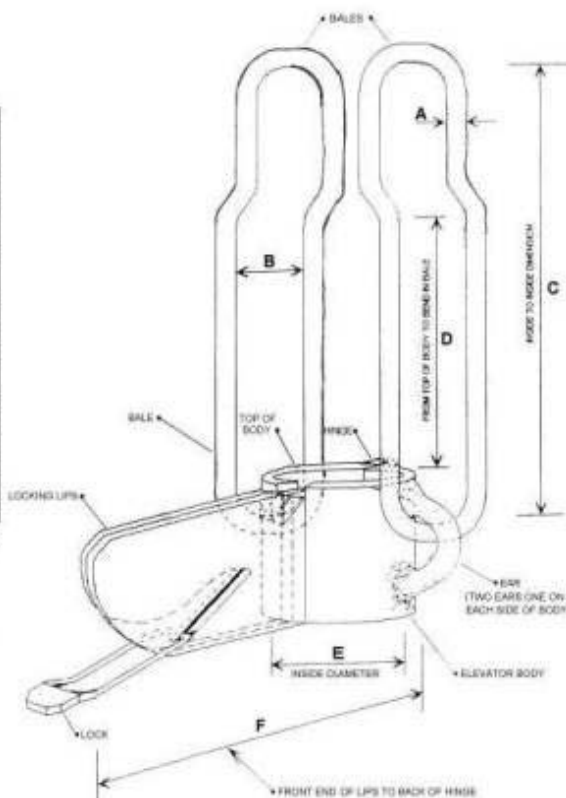
CSA 198
Attachment 1
Page 1 of 1

A. An activity reported the failure of two Standard Manufacturing Co. pipe elevators during load testing of size 4 and size 5 pipe elevators, (see Pipe Elevator Specification Sheet). The load ratings marked on the OEM tags were 84,000 lbs and 78,000 lbs respectively. The pipe elevators were each being tested to 125 percent of an administrative down rating of 50,000 lbs. The size 4 elevator failed in yield and the size 5 elevator failed in fracture at a test load of 62,753 lbs.

B. Based on available OEM data, the load ratings for the pipe elevators do not appear to satisfy ASME B30.20 or ASME BTH-1 design factor requirements. Navy Crane Center has been unsuccessful in obtaining any additional information from the OEM.

A. Activities shall immediately remove all Standard Manufacturing Co. pipe elevators from service. If additional information is received from the OEM demonstrating that these devices do meet ASME B-30.20 and ASME BTH-1 requirements, further direction will be provided in a revision to this CSA.
