# THE CRANE CORNER

## *Navy Crane Center Technical Bulletin*

84th Edition – December 2014

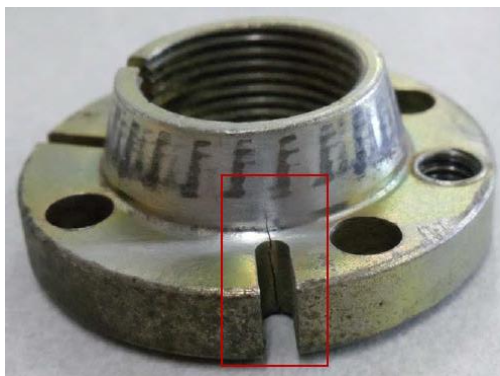
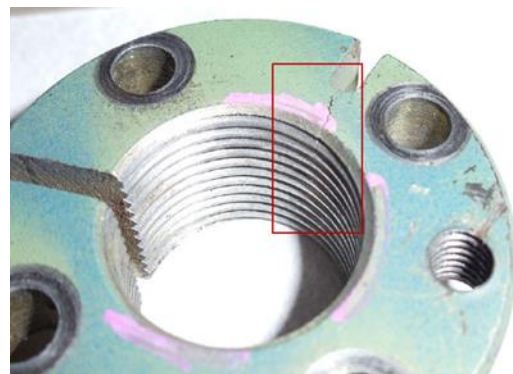
### **CSA 216 – CRACKED BRAKE ADJUSTMENT NUT ON A DEMAG TYPE KBA 100B4 BRAKE MOTOR**

A. The purpose of this CSA is to inform activities of a potential deficiency with the brake adjustment nut in the Demag Brake Motor, Type KBA 100B4. During annual brake inspections, an activity was unable to maintain the specified adjustment for the hoist brake in a 21 year old creep drive motor. After disassembly of the motor's brake, visual inspection of the adjustment nut revealed a crack through the thread body. The adjustment nut is identified as item 8 in Mannesmann Demag Clutch and Brake Adjustments Motors and Microspeeds Manual.

B. The OEM confirmed that the adjusting nut is unique to the Demag type "KBA" conical rotor brake motors; the OEM is not aware of other cracked brake adjustment nuts. The KBA 100B4 brake motor continues to be used by Demag in new equipment designs.

Activities with Demag Type KBA conical rotor brake motors shall compare the latest hoistbrake air gap (axial displacement measurement) with previously recorded measurements on file to evaluate if there is a pattern of inconsistent measurements. If a pattern of inconsistent measurements is determined, the motor shall be disassembled prior to or during the next annual maintenance period in order to inspect the brake adjustment nut for cracks.

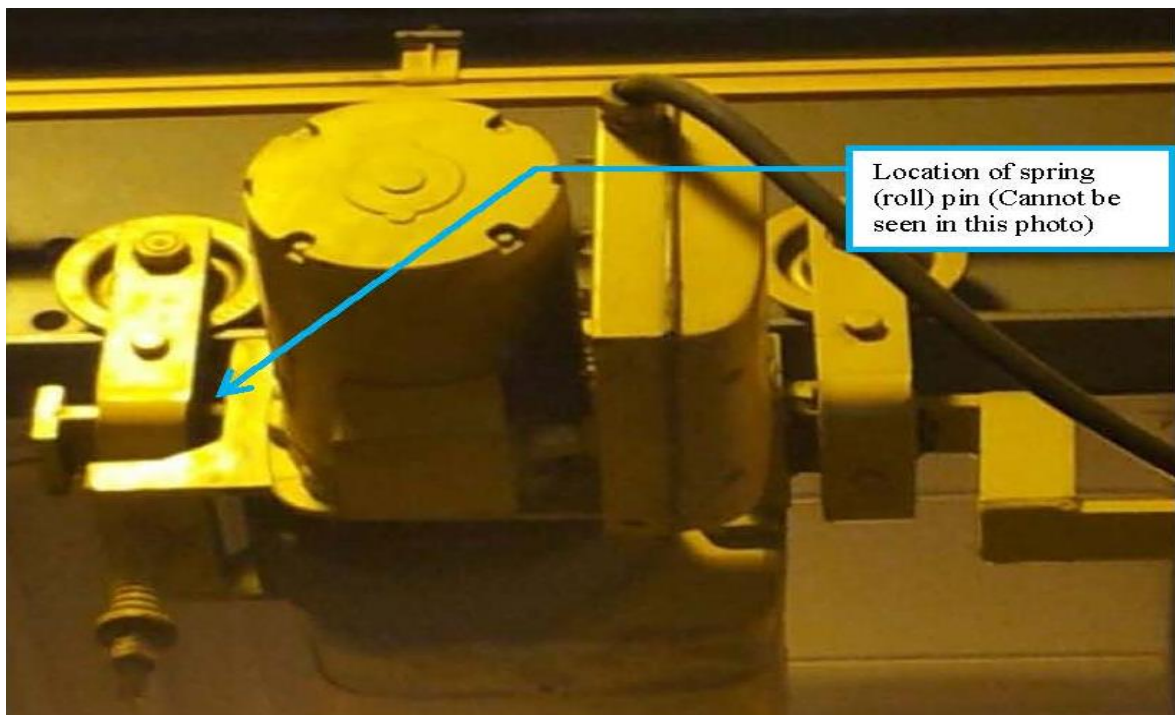
## **CSA 217 – BROKEN ROLL PIN IN WRIGHT-WAY TRACTOR DRIVES**

A. The purpose of this CSA is to inform activities of a potential deficiency with the roll pin used in the suspension assembly on Wright-Way tractor drives for use on patented track. During an activity's crane maintenance inspection, two monorail tractor drive units on two different cranes had broken roll pins, which were discovered after their removal even though they appeared to be intact. The activity reported that one of the failed roll pins led to parts falling from the crane. The subject roll pin (item 9, part number PA 5391) secures the tension adjustment rod in the tractor drive assembly.

B. The manufacturer is not aware of broken roll pins in other Wright-Way tractor drives and confirmed Revision B is the current drawing. This pin is used on tractor drives mounted on 2 inch, 3.25 inch, and 3.33 inch patented track flange widths for hoists with a maximum capacity of 5 tons. Wright-Way product numbers for applicable tractor drives are 2300080, 2300110, 2300090, 2300120, 2300220, 2300230, 2300240, 2300250, 2300260, 2300270, 2300280, 2300290, and 2300300.

A. Activities with cranes that utilize the Wright-Way tractor drives specified above shall remove the roll pin (part number PA 5391) during the next annual maintenance inspection and replace it with a new pin. Activities finding broken or excessively worn pins shall report results back to the Navy Crane Center. ■

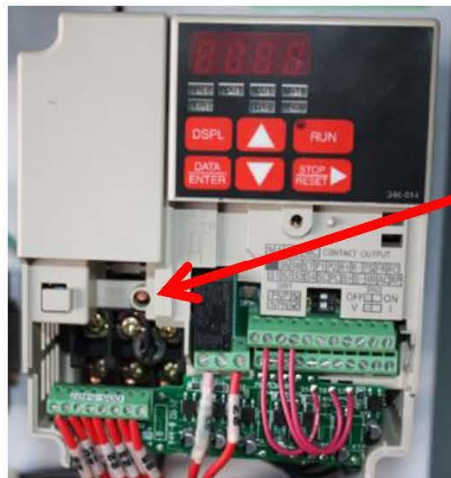
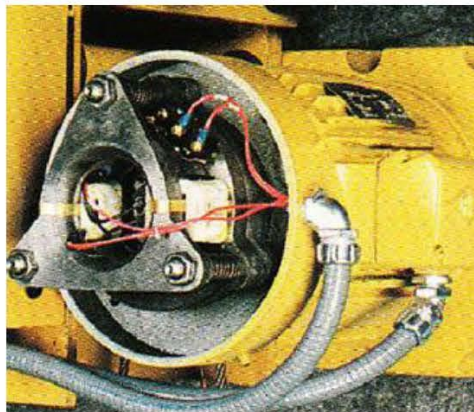
**Charge  
Indicator LED**

**Wright  
work-rated  
brake**

Incomplete servicing specifications due to **failure to incorporate original equipment manufacturer (OEM) manuals and instructions** can lead to **hazardous conditions**. Activities are reminded to review all OEM literature to ensure their maintenance procedures incorporate all OEM instructions and safety precautions, and **include all the features for their specific equipment**. Recent examples of incomplete servicing specifications reported to the Navy Crane Center include:

- Magnetek microprocessor drives are equipped with a charge indicator light to notify servicing personnel of the condition of the drive's DC bus voltage (see picture on left). **Work was performed within a control panel where the DC bus voltage was not at a safe level contrary to the OEMs safety guidelines for servicing their equipment.** This incident could have resulted in personnel being shocked.
- Wright Work-Rated hoists are equipped with an interlocking switch designed to prevent the hoist motor from starting before the brake is released. This switch was found out of adjustment after it was reported the load would drop approximately ½" when pressing the up button. **Personnel at the activity were unaware this feature existed.** This incident could have resulted in unplanned contact.

As stated in NAVFAC P-307, paragraph 2.5.2, **servicing specifications shall be developed using OEM manuals and instructions** for all mechanical and electrical equipment.

By ensuring servicing and maintenance procedures include all pertinent OEM information, **potential hazards can be avoided.**
