THE CRANE CORNER

Navy Crane Center Technical Bulletin

85th Edition – March 2015

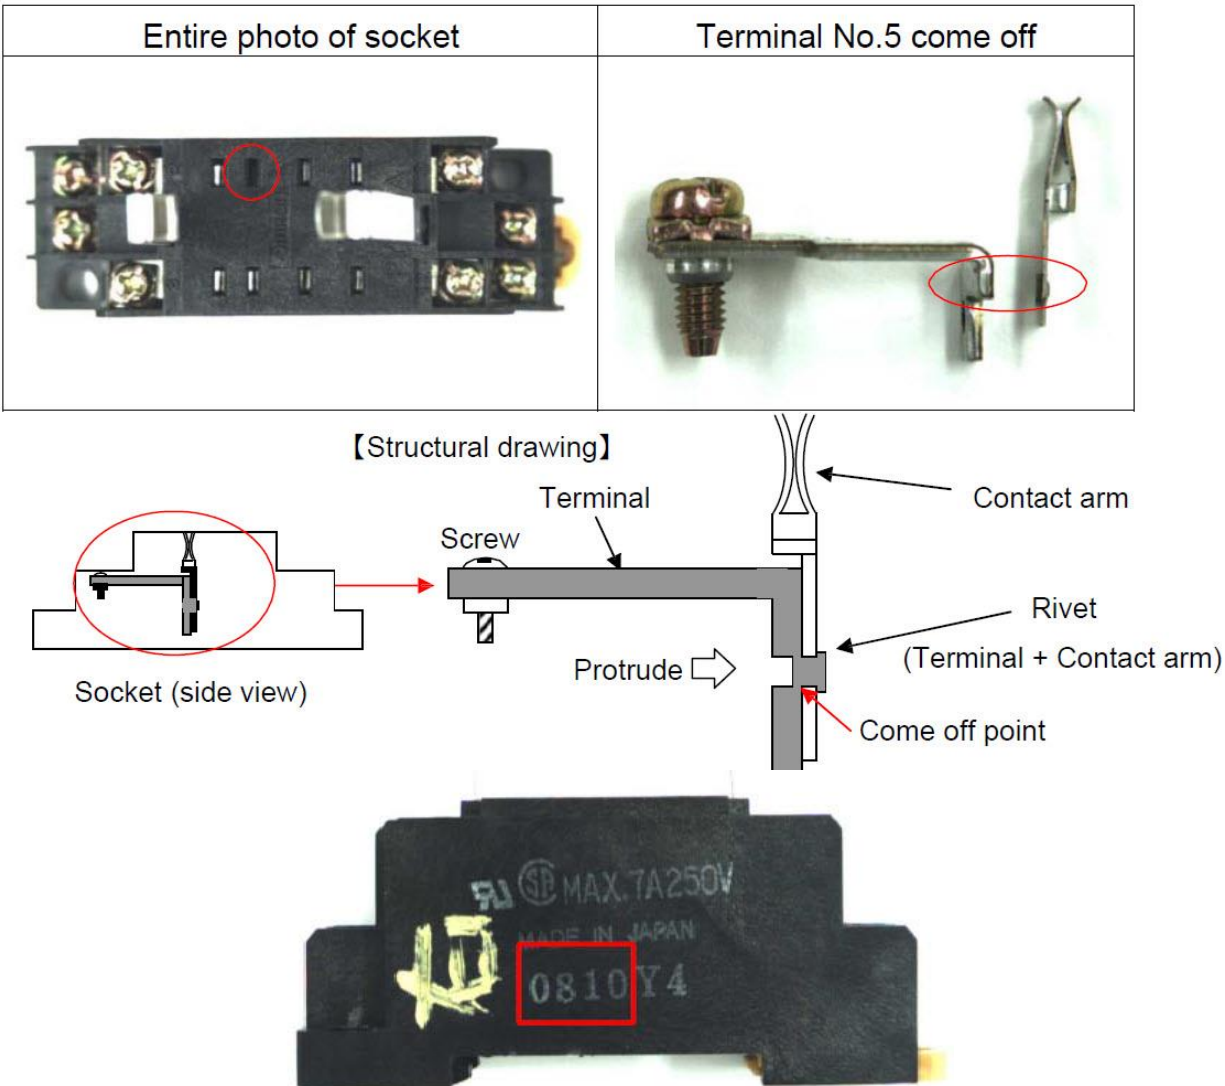
A. The purpose of this CSA is to inform activities of a potential deficiency with relay sockets manufactured by Omron Relay & Devices Corporation. The subject relay sockets have the part number PYF08A and are used in combination with Omron type MY2 ice cube relays. It is reported that pin 5 on the potentially deficient sockets may detach due to insufficient crimping and may result in the pin connection in the middle of the socket base becoming disconnected from the conductor screw terminal on the outside of the socket base. These types of relays are most commonly used on cranes that utilize electronic controls.

B. An activity reported a failure of an Omron PYF08A relay socket on Meiden bridge travel panel located on a bridge crane manufactured by Nippon Crane. Failure of this relay socket caused a speed point not to operate correctly. Discussions with Omron indicated that these relay sockets were not directly distributed in the United States.

C. Omron has acknowledged the problem with the PYF08A relay sockets and has determined that the problem resulted from improper riveting on specific sockets manufactured between November 2, 1999 and March 8, 2000. The lot #numbers of the deficient relay sockets all end in Y4(XXXXY4) and are as follows: 02Y9, 03Y9, 04Y9, 05Y9, 06Y9, 08Y9, 09Y9, 10Y9, 11Y9, 12Y9, 15Y9, 17Y9, 18Y9, 19Y9, 22Y9, 24Y9, 25Y9, 26Y9, 27Y9, 29Y9, 01Z9, 02Z9, 03Z9, 06Z9, 07Z9, 08Z9, 09Z9, 10Z9, 13Z9, 14Z9, 15Z9, 16Z9, 17Z9, 20Z9, 21Z9, 22Z9, 24Z9, 25Z9, 27Z9, 0510, 0610, 0710, 0810, 1110, 1210, 1310, 1410, 1510, 1710, 1810, 1910, 2010, 2110, 2410, 2510, 2610, 2710, 2810, 0120, 0220, 0320, 0420, 0720, 0820, 0920, 1020, 1420, 1520, 1720, 1820, 2120, 2220, 2320, 2420, 2520, 2820, 2920, and 0130. The lot #number can be found stamped on the side of the socket in white.

A. For activities located outside of the United States and Europe, prior to or at the next annual maintenance period, activities shall identify if they have any Omron PYF08A relay sockets with the lots #numbers that are identified in the background. Activities that find affected sockets shall obtain replacement relay sockets from Omron and notify Navy Crane Center.

B. For activities located in the United States and Europe, prior to or at the next load test certification (Cat 2 and 3 cranes) or C maintenance period (Cat 1 and 4 cranes), activities shall identify if they have any Omron PYF08A relay sockets with the lots #numbers that are identified in the Background. Activities that find affected sockets shall obtain replacement relay sockets from Omron and notify Navy Crane Center.

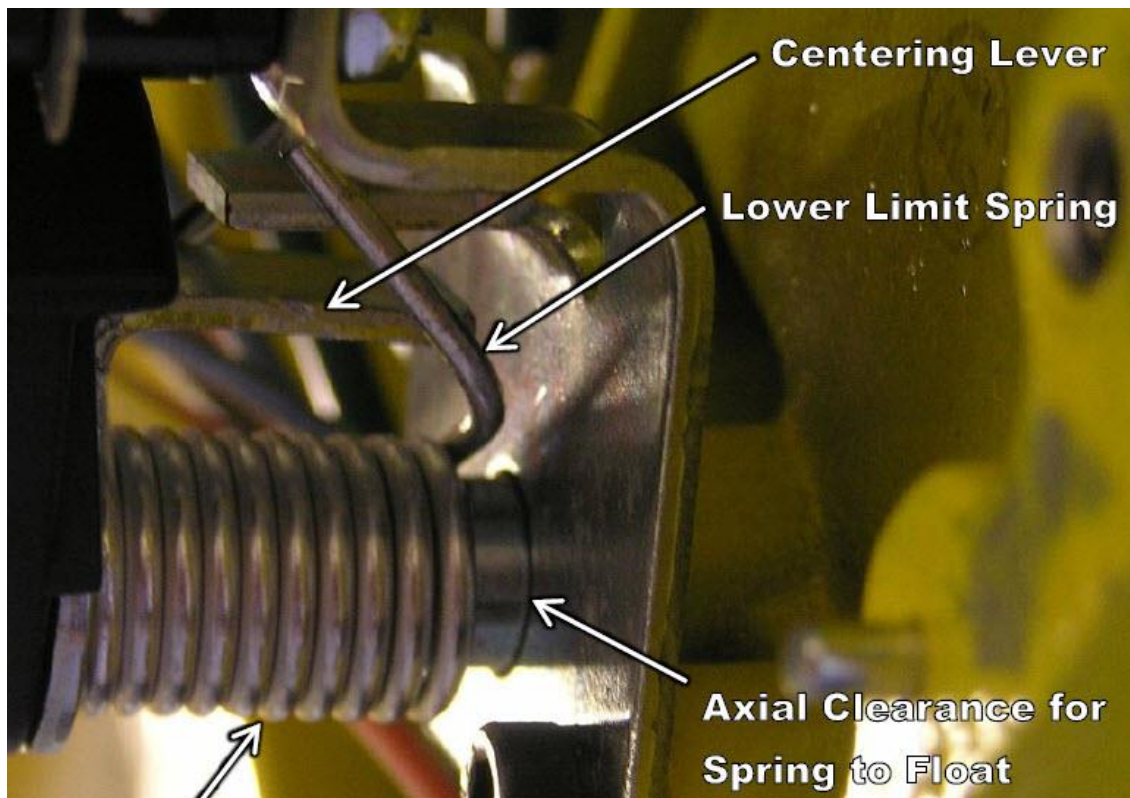
A. The purpose of this CSA is to inform activities of the potential for the hoist lower limit on Budgit model BEHC chain hoists to remain in the activated position even after exiting the lower limit, restricting the ability to hoist down.

B. The OEM has identified that the original design of the limit switch and shaft assembly (Part Number BH-1850) allowed for excess spring lateral float, which may cause the tab of the spring actuator to slip off the centering lever. This condition will cause the lower limit to remain active even after exiting of the lower limit. The OEM has redesigned the limit switch by lengthening the centering lever within the limit switch assembly to prevent slippage of the spring tab. The

part number for the centering lever, BH-1862, has not changed. This change also affects Yale KELC, Yale KELB, and CM Man Guard hoists which are identical to the Budgit BEHC hoist except for brand name.

Direction: Before or during the next annual preventative maintenance period, activities shall replace the limit switch centering lever (part number BH-1862) on Budgit BEHC, Yale KELC, Yale KELB, and CM Man Guard hoists manufactured before September 24, 2014.

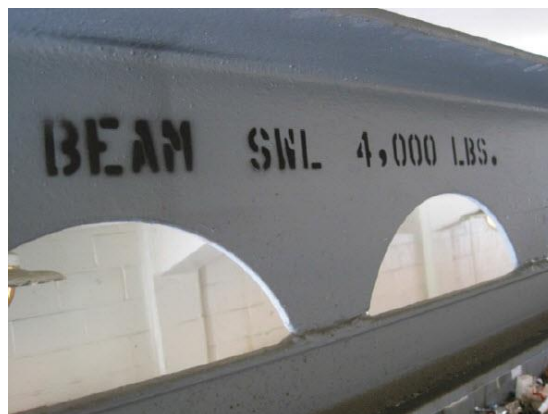
Tramrail Arch Beam

A. The purpose of this CSA is to inform activities of the possibility of weld failure in Arch Beams manufactured by Cleveland Tramrail. Cleveland Tramrail is now owned by Gorbels, Inc. Gorbels has issued a warning of the possible dangers of age and fatigue in the welds of Arch Beams. Arch Beams (also known as castellated beams) may be identified by the half circle cutouts in the web of the beam. The Arch Beams in question can also be identified by the name Cleveland embossed on the web of the beam. Arch Beam track was phased-out of production in 1962 and replaced by Tarca Beams.

B. Navy Crane Center has conducted independent inspections of Arch Beam samples and has found most of the Arch Beam web to bottom flange welds to be of poor quality containing numerous discontinuities. An additional evaluation by another Navy activity of extensive weld inspections of Arch Beams noted various weld discontinuities and cracks that were formed

during fabrication, but revealed no crack propagation from continued use. Based on these inspections, it appears that many of these beams were fabricated using poor weld processes and minimal quality control. Navy Crane Center recommends using AWS B1.1 and AWS B1.10 to assist activities in the identification of defects during weld inspections.

A. Within the next 180 days, activities shall evaluate their inventory for Arch Beams manufactured by Cleveland Tramrail. Activities shall report to Navy Crane Center all in-service installations of Arch Beams, including building location and approximate length. Out-of-service Arch Beam locations that are intended to be put back in service at a later date shall also be reported.

B. Activities that have identified Arch Beams manufactured by Cleveland Tramrail in their facilities shall continue to perform a visual inspection of welds during every annual inspection as is currently required by NAVFAC P-307. Prior to Arch Beam inspection, Navy Crane Center recommends removing only the dust and dirt covering the welds (without removing paint) due to the likelihood that the paint on the Arch Beams contains lead and should be treated as such until proven otherwise.

C. During the next annual visual inspection, activities with Arch Beams shall pay special attention to the welds that connect the bottom flange to the web. These inspections shall include the use of 5X magnification on suspect areas. Suspected cracks identified during inspection shall be verified by nondestructive inspection. Any Arch Beam section identified as having weld cracks shall be removed from service and reported to Navy Crane Center. Defects in welds, excluding cracks, are not necessarily rationale for removing the Arch Beams from service; however, the defects shall be documented.

D. Weld repairs to Arch Beams are not authorized due to the unknown carbon content of the steel. The Arch Beam webs were manufactured from ASTM A7 steel and the material specifications at the time of manufacture did not require the control of carbon content. Unsatisfactory sections of Arch Beam shall be removed from service and replaced using the Crane Alteration process. Tarca beam is a direct substitute that will match existing Arch Beam sections that pass inspection.

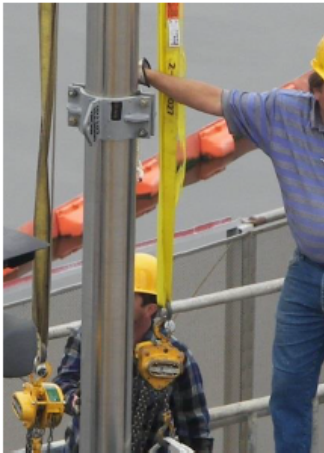
A Rigger became distracted and placed his hand in a "**pinch point**" between the webbing sling and the suspended load that was moving. Wave action against the floating crane could cause the load to rise and lower trapping the riggers hand or fingers. **Never place your hands between the rigging gear and the load.**

Crane Rigger positioned himself in a "**pinch point**" as he signaled the crane to up-right a 20,000 pound tower crane counter weight. If the weight slid toward him he would be crushed.

****Signal the crane from the ground, if the load does slide no one will be injured.**
