# THE CRANE CORNER

Dec 2018  
100th Edition

## *Navy Crane Center Technical Bulletin*

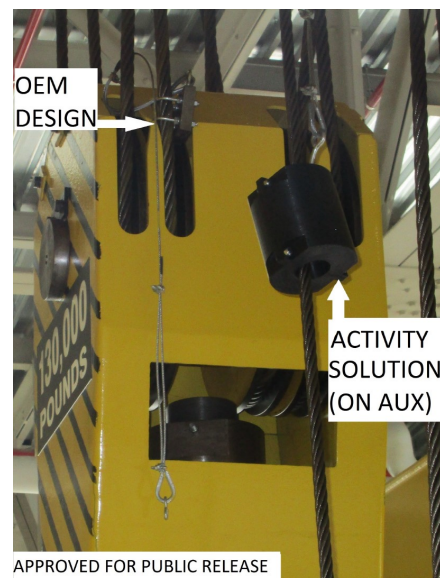
### **EDM 110 – POTENTIAL FOR UPPER LIMIT SWITCH WEIGHT TO BECOME LODGED IN LOAD BLOCK**

A. An activity reported the secondary upper limit switch weight had become lodged in the main hoist block when backing out of the limit. The design featuring two U-bolts and a flat steel plate has the ability to be caught in the sheave opening of the block and is standard on most Crane Technologies' bridge cranes. The activity corrected this deficiency by replacing the weight with a cylindrical clamshell style weight.

B. Navy Crane Center recommends that during the next scheduled maintenance inspection activities with bridge cranes manufactured by Crane Technologies inspect the load block for the potential of the upper limit switch weight to become wedged in the load block. If necessary, the activity should make the appropriate crane alterations to modify the weights to prevent them from entering the block or change to a different style weight. Modifications to the existing block or upper limit switch require the activity to submit a crane alteration request to Navy Crane Center for approval per NAVFAC P-307.

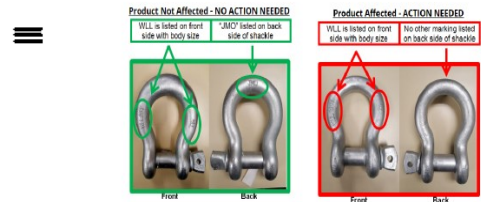
## Important Product Recall - Dayton Anchor Shackles and D Shackles

Dayton Electric Manufacturing Co. ("Dayton") is recalling the Dayton anchor shackles and D shackles that are identified as being incorrectly listed as meeting federal specification RR-C271. Dayton recently conducted proof load and break load testing on a sample of the Dayton anchor shackles and D shackles, some of which did not meet our testing standards. Although there have been no reported injuries or damage related to the shackles, out of an abundance of caution, we are recalling all of the items in the product line that were obtained from a particular supplier and were sold beginning in October 2016. If you have any of the items identified in this notice, please immediately remove them from service.

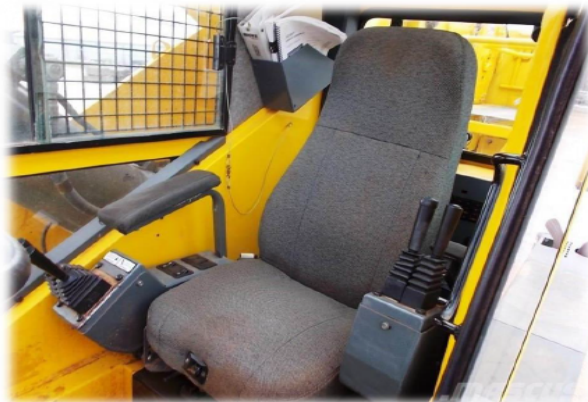
Recent evaluations have identified an increasing trend of unfamiliarity with operational safety devices on mobile cranes. The following features and components shall be checked:

**Operational Safety Devices** – In addition to the typical Load Moment Indicator or Rated Capacity Limiter mobile cranes are often equipped with other functional interlock devices such as operators seat or push button "deadman" switches or moveable armrest console that disable all functions when tilted back.

**ODCL Checks** - During the operational portion of the ODCL, operator's shall verify proper operation of all these operational safety devices verifying lockout of all functions. NAVFAC P-307, paragraph 9.1.2.1.4.j

**MISR and CCIR Inspection Attributes** – These additional interlock switches shall be inspected as appropriate during the MISR (NAVFAC P-307, Appendix C, Note 9) and proper operation verified during the no-load test/CCIR. (NAVFAC P-307, Appendix E, paragraph 1.1)
