THE CRANE CORNER

Sept 2019
103rd Edition

Navy Crane Center Technical Bulletin

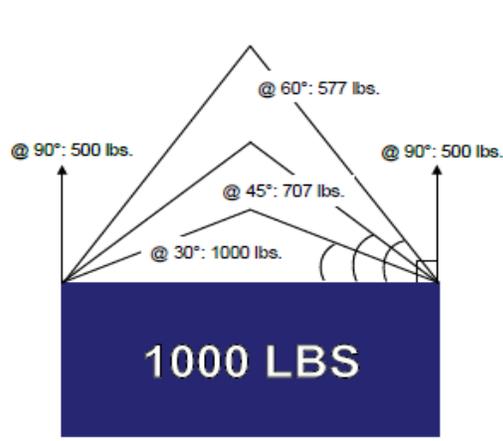
The load seen by a sling changes based on the angle of the slings.

- In the figure shown on the left, the center of gravity is located in the center of the load. In this case, the load on each sling at 90° [from horizontal] would be 500 lbs, but if the sling angle was decreased to 60° [from horizontal], the added sling angle stress would increase the load on each sling to 577 lbs. As the sling angle continues to decrease, the load seen by each sling continues to increase as shown.

- NAVFAC P-307 prohibits the use of slings at angles less than 30° [from horizontal] unless authorized by an engineering work document.
- The affect of the **sling angle stress must be considered** when calculating/selecting gear size and capacity.

Personnel involved in the planning and rigging of loads must calculate the load in each sling and other rigging components to ensure an overload does not occur.

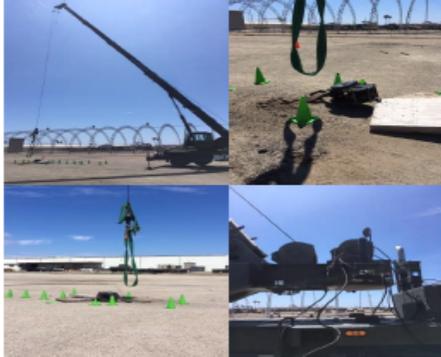
In July, a two-block accident occurred that resulted in **the main hoist block detaching from the crane**. This was the second two-block to occur within a two-month period on a mobile crane equipped with an anti two-block feature. Both of these events occurred because of improper operation (human error). This brief discusses the events and emphasizes important lessons learned.

- In the first event, the operator disabled the anti-two block safety device in preparation to stow the boom and travel the crane. The rigger-in-charge (RIC) signaled the operator to retract the boom and began removing slings from the crane hook. The operator fully retracted the boom and proceeded to lower the boom and raise the hoist without direction, resulting in a two-block. **Lessons learned:** Crane Operator's are required by NAVFAC P-307, Section 10, to make movements during crane operation only when given the direction to do so. Additionally, the RIC performed functions that compromised their control of the evolution.

- The second event occurred during a training evolution when an operator under instruction was making a lift. The operator was instructed to boom down; however, the operator began scoping out instead. The RIC was distracted and not watching the lift while the operator continued scoping the boom until the main hoist two-blocked, breaking the main hoist wire, causing the block to fall to the ground. **Lessons learned:** The RIC was distracted and did not ensure signals were provided to the operator. The operator was under instruction and was not directly supervised by a licensed operator contrary to NAVFAC P-307, Paragraph 8.7.

The pictures above illustrate damage that resulted from a recent two blocking event.

It is important to remember that NAVFAC P-307, Section 10.2.2.3., requires personnel to be thoroughly trained on the operation of safety devices. Additionally, each activity is required to develop procedures to control bypassing of safety devices.
