# THE CRANE CORNER

Dec 2021  
112th Edition

## *Navy Crane Center Technical Bulletin*

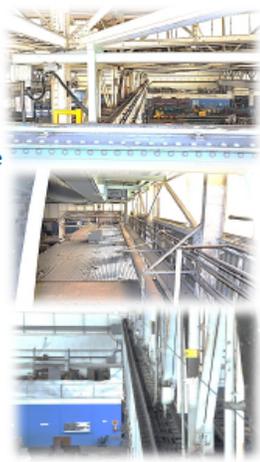
**Recent Accidents:**

- A monorail crane control box made contact with a newly installed structure.
- A bridge crane collector shoe made contact with bailing wire left by contractors working in the area.
- A bridge crane handrail collided with an overhead fire main pipe protruding into the crane operating envelope.
- A crane hot rail collector shoe wire caught on a bolt.
- A bridge rail contacted newly installed electrical conduit.

**Suggested Actions:**

- During facility maintenance, management should consider potential options, such as full isolation of the crane until facility work is complete or installation of temporary rail stops (with a locally approved crane alteration request, per NAVFAC P-307, paragraph 6.3) to isolate the crane from the area of potential crane clearance intrusions. Note: It would be prudent to also consider the use of local equipment tagging procedures (NAVFAC P-307 paragraph 2.8.2) to identify conditions that may adversely affect safe operation.

- During clearance checks, check wheel float, and all trolley positions and configurations.
  - Check for items that have the potential to loosen and become future crane clearance intrusions.
