THE CRANE CORNER

Navy Crane Center Technical Bulletin

45th Edition Web Version- March 2005

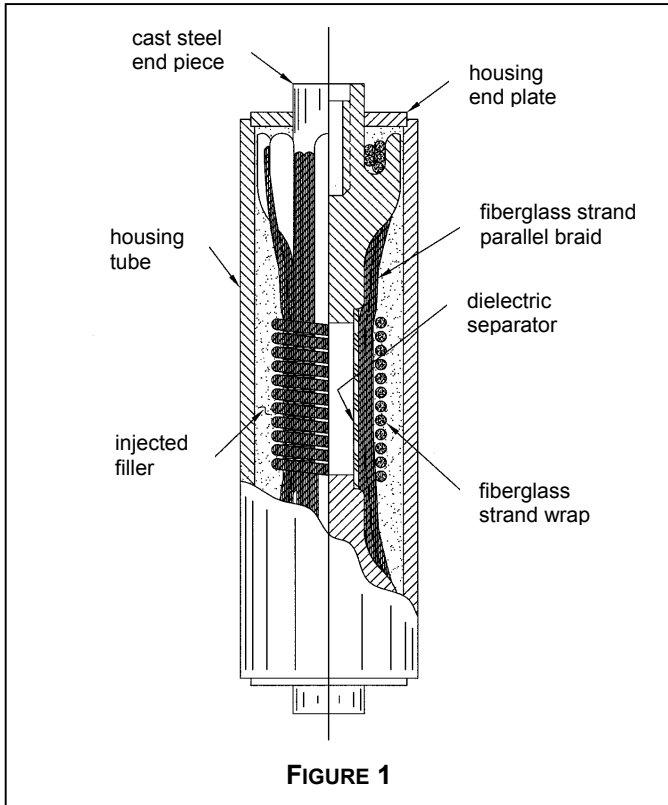
A relatively simple device known as an electrically insulating link (load insulator, radio frequency (RF) link) can dramatically increase the survivability of riggers working in close contact with the load. They are constructed with one basic principle, electrically isolate the load from the rest of the crane. These devices can also provide protection against RF energy coupling to the crane structure. This energy can cause burns and damage sensitive electronic loads if not properly isolated. These devices do not protect against lightning strikes, which pack more power than they are rated to handle. Figure 1 illustrates the construction of one such device. There are a variety of electrical and rated load configurations available.

The selection of an insulating link should be made with care since they come with many different ratings: maximum voltage, AC or DC, rated loads in tons, wire rope size, and electrical and mechanical safety factors. The rigging configuration is also important. Rigging can be: hook at bottom, stud at top; hook at bottom, bail at top; bail at both ends; or threaded studs at both ends. ■
