THE CRANE CORNER

Navy Crane Center Technical Bulletin

65th Edition – March 2010

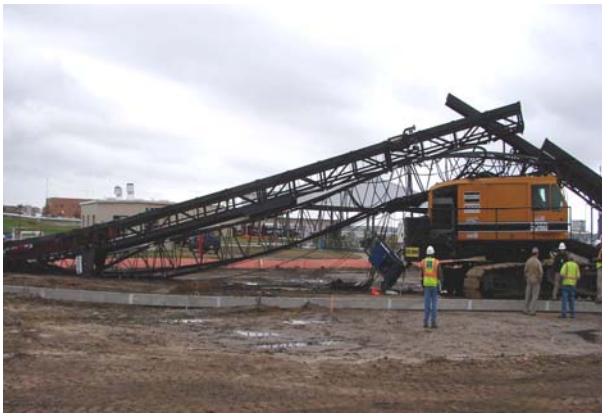
A contractor recently had an accident during pile driving operation. The crane had a 110' x12"x 12" concrete pile in the leads when a loud pop sound was heard. The leads dropped straight to the ground and the boom recoiled backwards, striking the boom stops. The leads followed the boom, overcoming the boom stops, and both the boom and leads fell backwards over the centerline of the crane. Luckily, no personnel were injured.

Upon investigation, it was found that modifications to the boom for attachment of the pile driving leads were not properly engineered or approved by the crane OEM or a qualified person. Two brackets were welded to the underside of the crane boom and the pile driving leads were attached to these brackets with a pin. The brackets were welded to a non re-reinforced section of boom chord. The boom chord failed in the bracket attachment area causing the accident described above.

Inspection of the crane prior to operation on a Navy facility, per the P-307 appendix P, did not reveal any problems with the pile driver lead attachments. No documentation was received or requested on the attachments. They appeared to be in good condition.

Pile driving attachment points should be inspected by Navy personnel prior to operating to ensure the connection method has been documented and approved by the crane OEM, pile driving attachment OEM, or a professional engineer.

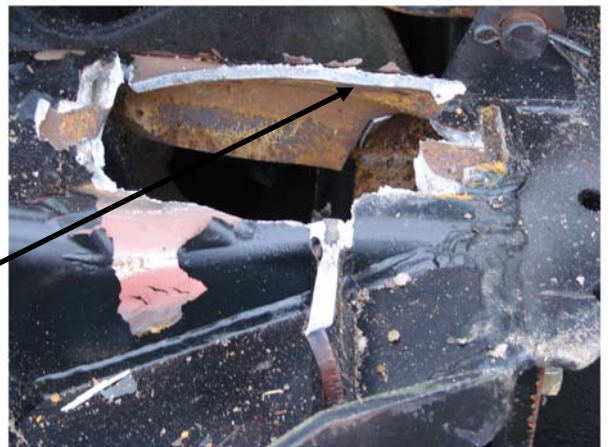
Attachment point of the leads to the underside of the boom chord. The chord material was not properly sized to handle the loading. ■
