THE CRANE CORNER

Navy Crane Center Technical Bulletin

78th Edition – June 2013

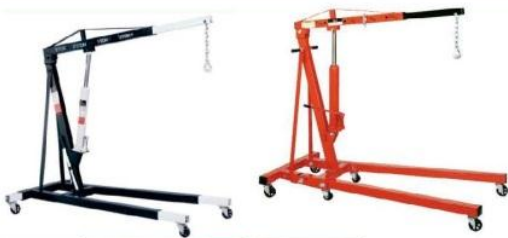
- Navy Activities have reported at least four recent instances of structural failure occurring during 125 percent load testing of **2 ton portable floor cranes (engine lifts)**. This tool is commonly used in auto repair shops as well as industrial machine shops.

- As a result of these failures, Navy Crane Center has directed (via Crane Safety Advisory (CSA) 205) that **all two-ton floor cranes manufactured by Walter Meier Manufacturing and Shin Fu Company of America be removed from use immediately**. These include 2-ton floor cranes sold under the following trade names:

- **Pro-Lift – Model "T-1481"**
- These floor cranes shall remain out of service until a solution to the repeated structural failures can be obtained. At this time, no other 2-ton floor crane models are affected. NAVCRANECEN will revise CSA 205 as additional information becomes available.

- Activities shall notify NAVCRANECEN (NFSH_NCC_INSERTSERVICE_ENGINEERING@NAVY.MIL) of the Manufacturer/Distributor and model/serial number for each portable floor crane removed from service.
