# THE CRANE CORNER

## *Navy Crane Center Technical Bulletin*

79th Edition – September 2013

### **CSA 206 – Coffing Chain Hoist Model LLH 1 Ton Manual Chain Hoist**

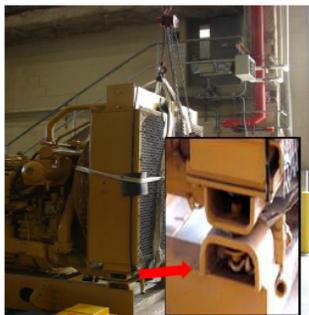
**CONSTRAINED LIFT**

Portable Load Indicating Device with chain fall

Crane & rigging gear **overloads** are significant accidents with potentially severe consequences including dropped loads, damaged equipment, and injury to personnel. A negative trend in the occurrence of potential crane or rigging gear overloads due to **lifting loads that are constrained** (binding condition) or lifting loads that are **anchored (fasteners left in place)** has been identified.

- **Know, or have a reasonable estimate of, the weight to be lifted.**
- **Know the weak link** in your rigging gear configuration and **do not exceed.**
- **Remove all hold-down fasteners. Ensure the load is free to lift. A SECOND CHECK IS ALWAYS ADVISIBLE!**
- **Portable load indicating devices (LID)** will be used when overload due to binding conditions is possible. The LID readout shall be readily visible to the signal person or RIC. A LID should also be utilized where it cannot be positively verified that all hold-down fasteners have been removed.
- **Stopping points** shall be **established, LID monitored** and stopping point **not exceeded.**
- **Chain falls, or other hoisting control means,** shall be used to avoid sudden overload when necessary.
