THE CRANE CORNER

Navy Crane Center Technical Bulletin

83rd Edition – September 2014

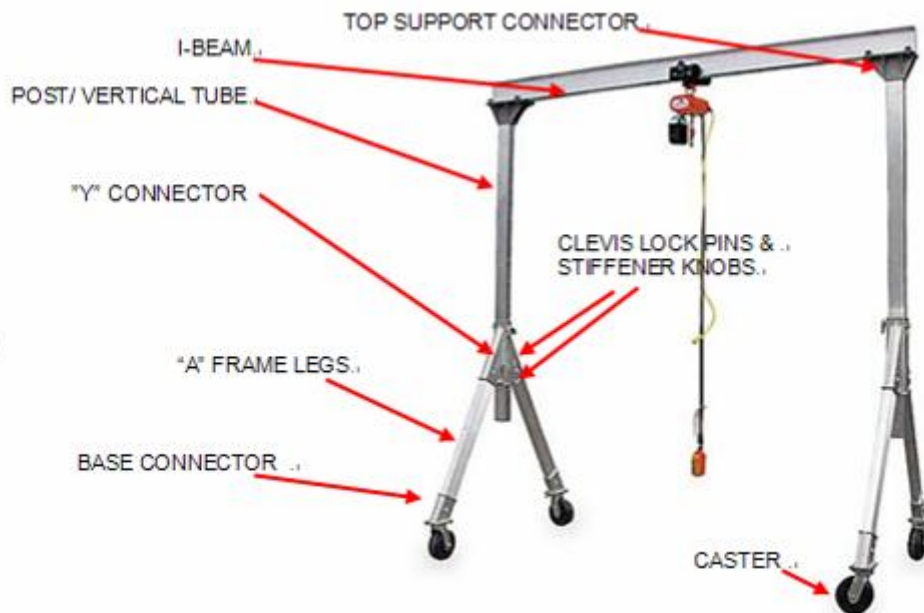
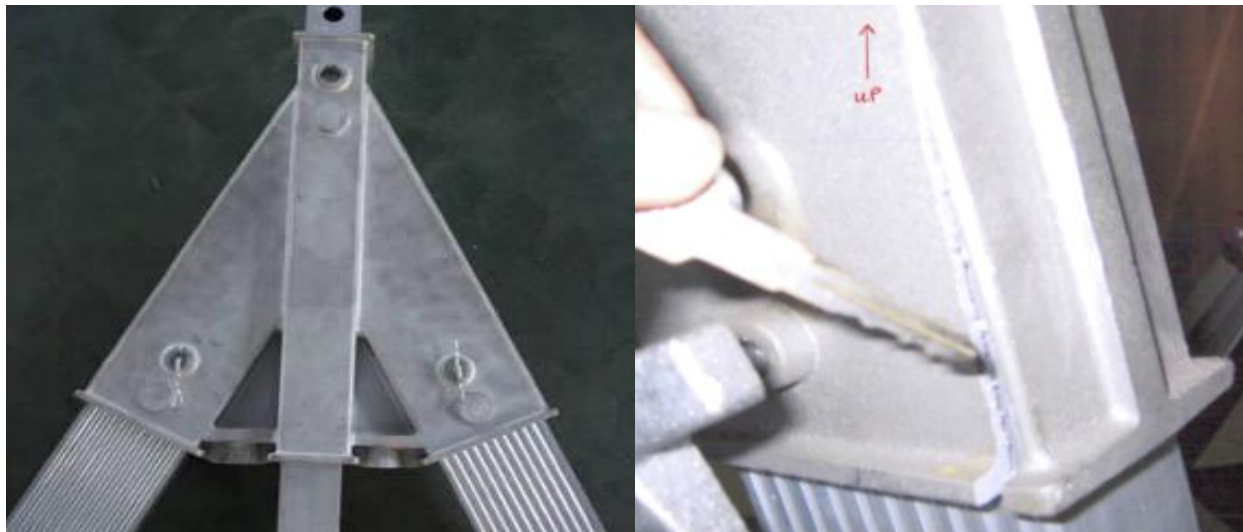
CSA 213 – FAILURE OF Y CONNECTOR ON A DAYTON PORTABLE GANTRY A-FRAME CRANE

A. An activity reported that the Y connector on a Dayton Model 4EER4 portable gantry/A-frame crane cracked during a load test. The Y connector reinforces the legs of the gantry. The crack was approximately four inches in length which allowed the load to drop 1 to 2 inches. The activity failed to add the weight of the hoist and trolley to the total weight being tested and therefore the test load was exceeded by 63 lbs. The activity successfully completed a static load test with this weight but as they started to move the crane (with load) for a travel test, the Y connector failed. Moving the crane with a suspended load is not in accordance with the OEM's instructions.

B. The OEM did not believe that the crack in the Y-connector should have occurred with such a small overload. The OEM said that moving the crane with a suspended load over cracks in the pavement or an uneven rolling surface may have caused additional unwanted stress on the Y connector. The OEM Operating Instruction and Parts Manual states: "to never attempt to move gantry while loaded".

A. Activities shall replace the Y connector with the new design on Dayton models 4EER2, 4EER3, 4EER4, 4EER5, 4EER6, 4EER7, 4EER8 at or prior to the next annual maintenance inspection (Category 3 cranes) or periodic inspection (equipment covered by Section 14 of the NAVFAC P-307). Activities shall contact their local Grainger representative for replacement of this part. A local Grainger representative can be found at www.grainger.com and clicking on the "find a branch" link. Activities are reminded that traveling a portable gantry/A-frame crane is only permitted when allowed by the gantry/A-frame OEM. Understanding and complying with OEM requirements is vital for safe operation.

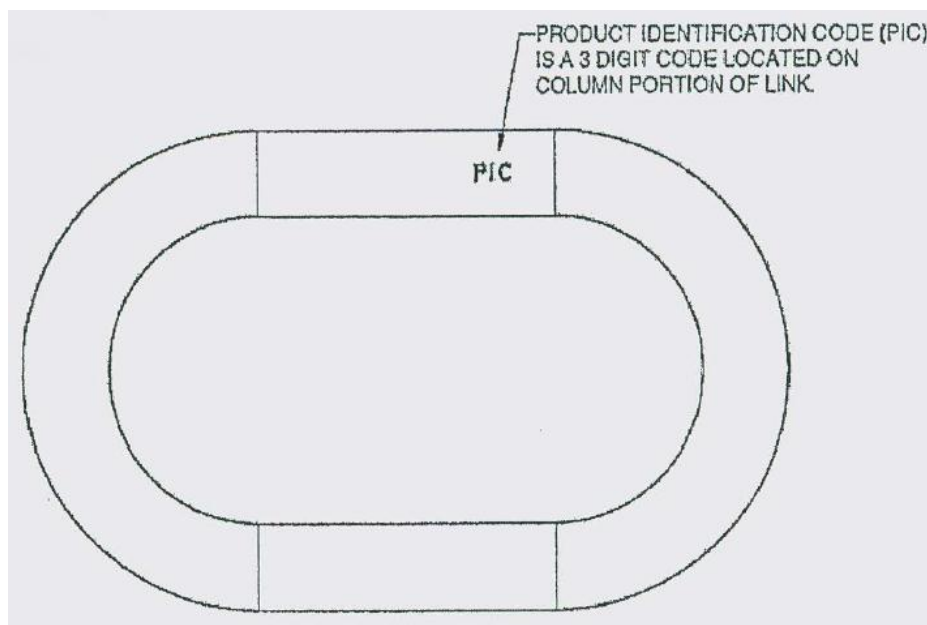
CSA 215 - POSSIBLE DEFICIENCY WITH CROSBY A-342 AND A-345 MASTER LINKS AND MASTER LINK ASSEMBLIES

A. The Crosby Group has discovered that a small percentage of A-342 Master Links (sizes 2", 2¼", 2¾", and 3") and A-345 Master Link Assemblies (sizes 2", 2¼", and 2¾") may fail prior to the intended design factor of 5. There have been no field failures reported but Crosby has identified failures during overload testing. Crosby has issued a safety alert to inform its customers of this issue. Crosby's safety alert is only applicable to Master Links and Master Link Assemblies matching the sizes and associated Product Identification Codes (PIC) shown in the table below. The PIC is a three-digit code located on the straight and flattened column portion of the link.

A. Activities shall remove from service and inspect all A-342 Master Links and A-345 Master Link Assemblies that match the size and PIC codes identified in the table below within the next 15 days. The inspection shall identify if the Master Links and Master Link Assemblies match the sizes and PICs covered by this CSA and Crosby's safety alert. Master Links and Master Link Assemblies found to not be covered by the safety alert may be placed back into service.
