# THE CRANE CORNER

March 2018  
97th Edition

## *Navy Crane Center Technical Bulletin*

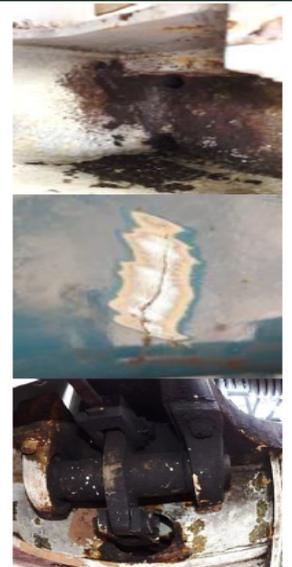
- **Event:** Recently, multiple activities have reported excessive metal loss (corrosion) or cracks in base material in load bearing areas on various crane types including bridge and mobile cranes, particularly in areas where it is more difficult to inspect. Late identification of these issues has resulted in an unrepairable material condition and the cranes were required to be removed from service. For the most recent mobile crane corrosion issue, the repair cost is estimated to be very high (>\$500K). These critical cranes will require evaluation on whether to repair or replace the cranes.

- **Noteworthy Items:**
  - Crane repositioning may be required in order to complete all inspections.
  - Cracks can form in areas outside of welds and bolted connections.

- When corrosion is found on one side of a member, the opposite should be inspected for corrosion as well.
  - Inspection instruments such as a borescope may be necessary to perform the required comprehensive inspections.

- **Lessons Learned:** Structural inspection attributes are included in NAVFAC P-307, Appendices C and D. These inspections comprise all areas identified on the crane, including areas in which inspections are difficult to perform or are inaccessible by regular visual inspection means including voids and crawl spaces. Early detection of corrosion issues allows for mitigation of problems before they become catastrophic.

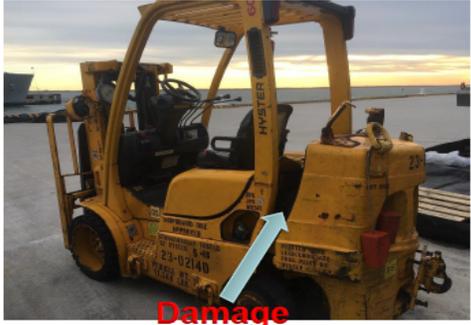
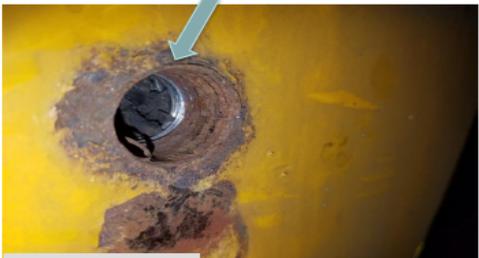
**Title: HYSTER MODEL S60FTG FORKLIFT LIFTING HAZARD**  
**Target Audience: WEIGHT HANDLING PERSONNEL**

NAVSUP WEAPON SYSTEMS SUPPORT Mechanicsburg, PA issued Naval message R071418Z FEB 18 following a ship's crane accident involving the lifting of a Hyster Model S60FTG forklift. The counterweight (lift point) separated from the forklift chassis during the lift due to suspected deterioration and/or improper torque values of the counterweight's single retention capscrew. Navy shore activities have the potential to lift this equipment. When lifting this particular model of forklift, consider the following:

- All ships that utilize this forklift were given direction to check the capscrew for proper pre-load torque prior to lifting.
- Apply extra caution when performing lifts of this model forklift and observe for any movement of the counterweight prior to the wheels leaving the ground.
- If in doubt as to the integrity of the connection, consider alternative lifting methods such as the use of approved platform or basket hitches with appropriate sling protection and frapping.
- Contact a rigging supervisor or the activity engineering organization for additional assistance as necessary.
- For questions regarding this forklift or message, contact MHE ISEA Bob Monroe, robert.j.monroe@navy.mil, 973-724-1449.

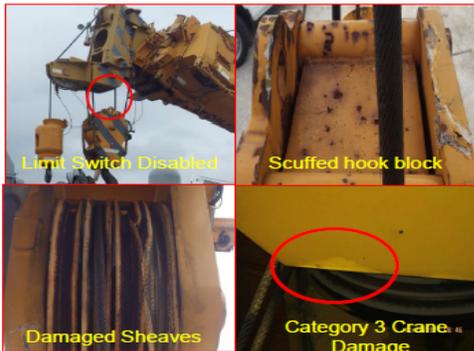
*These pictures illustrate damage that resulted from two blocking events.*

An increasing number of two-block accidents have been reported recently involving mobile and category 3 cranes. The majority of these two-block accidents were the result of improper operation (human error). **Nearly half of all two-block events this fiscal year have occurred during performance of maintenance, inspection, and testing.** This brief discusses several recent two-block events and emphasizes important lessons learned that may help prevent two-block accidents.

- An operator inadvertently pulled the wrong lever which raised the whip hoist through the anti two-block switch. **Lessons learned:** The operator should always visually verify the correct lever prior to engaging.

- While stowing the crane boom for travel, the operator deactivated the anti two-block limit switch on the main hoist and raised the main hoist while lowering the boom causing the main hook block to contact the boom sheaves. **Lessons learned:** Performing multiple functions at the same time made it hard to focus on accomplishing the task safely.

- During maintenance of the upper hoist limit switch, the team did not recognize the upper limit switch failed to stop the hoist and a two-block event occurred. **Lessons learned:** Personnel should exercise caution while testing a limit switch after repairs/maintenance. The limit switch could fail or be out of adjustment.

- A crane operator raised the main hoist to check the upper limit switch at high speed causing the hook block to drive through the limit switch. **Lessons learned:** NAVFAC P-307 paragraph 9.1.2.1.4(h) requires checking of limit switches be performed at slow speed. This method allows the operator to react when a limit switch does not activate as expected. In this specific case, the limit switch set point did not account hoist drift.
