Summary of Weight Handling Equipment Accidents, Second Quarter, FY18

CSAs

Weight Handling Training and Safety Briefs

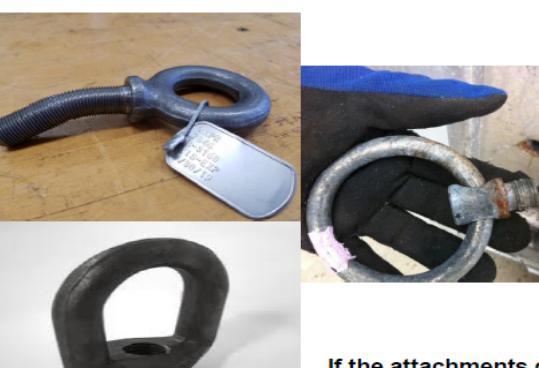
A recent crane accident was attributed to a threaded lifting attachment pulling out causing the load to drop to the ground. NAVFAC P-307, paragraph 14.4.2 requires equipment to be visually inspected by the user prior to use to verify rated load, marking, condition, and inspection status. In this specific event, the threaded attachment was not verified hand tight prior to lifting.

Prior to lifting any component with a threaded attachment, the crane team should verify all attachments are installed with the shoulder flush with the mounting surface and in the plane of the pull, unless approved by activity engineering.

☐ In the case of lifting attachments, the crane team should verify proper engagement of threaded attachments, no loose fitting components, and no evidence of pre-existing damage.

If the attachments do not fit correctly on the component to be lifted or have evidence of previous damage, do not lift the component.

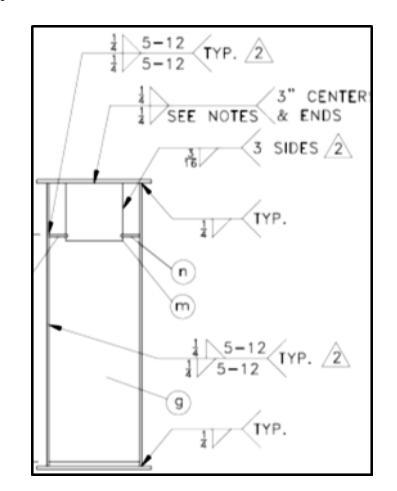
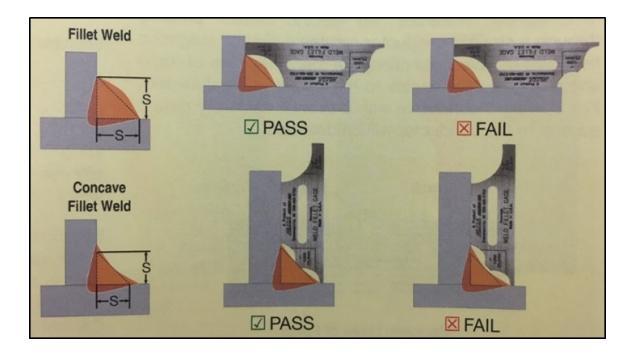
Here are examples of fillet weld gages being used to measure fillet welds. A typical fillet weld gage will have one end with a "single wave" profile and one end with a "double wave" profile. The "single" side is intended for convex welds where the limiting dimensions of concern are the legs (dimension S). A satisfactory convex fillet weld will at a minimum contact the gage at the top while the toe will extend at least to the black line on the gage. The "double" side is intended for concave welds and measures the effective throat (dimension E). For concave welds, the middle flat of the gage should contact the weld while the toes should extend beyond the black lines on the gage. It is equally important to consider the weld standard specified in a contract document when determining if a weld is satisfactory.

For example, AWS D1.1 and D14.1 both permit welds to be slightly undersized as long as the undersized area does not exceed 10% of the total length or occur at the ends of a weld length. In these codes, permissible undersizing is up to $\frac{1}{8}$ " depending on the specified weld size.

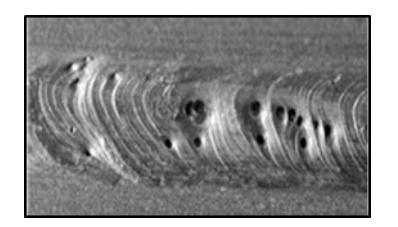
Another common issue in fillet welds is porosity. Porosity can occur for a number of reasons such as insufficient shielding (common in the windy conditions of field welding), welding over mill scale and grease, and carrying a short or long arc length. Like weld undersizing, it may not look pretty, but minor porosity is acceptable by many codes including AWS D1.1 and D14.1. The degree of acceptability will depend primarily on the code referenced in the contract documents and the type of loading the weld is subjected to. As an example, D1.1 states that for cyclicly loaded connections "the frequency of piping porosity in fillet welds shall not exceed one in each 4in of weld length and the maximum diameter shall not exceed 3/32in." There is different criteria for static connections within the same AWS code. A picture of unacceptable porosity (dark circles) in a cyclically loaded weld is shown here.

Note that both porosity and inadequate weld size are common to the industry. The presence of these deficiencies can have severe implications on the strength of a structural connection when they exceed code allowables, but correcting them are common practice and relatively easy.
