# THE CRANE CORNER

## *Navy Crane Center Technical Bulletin*

77th Edition – March 2013

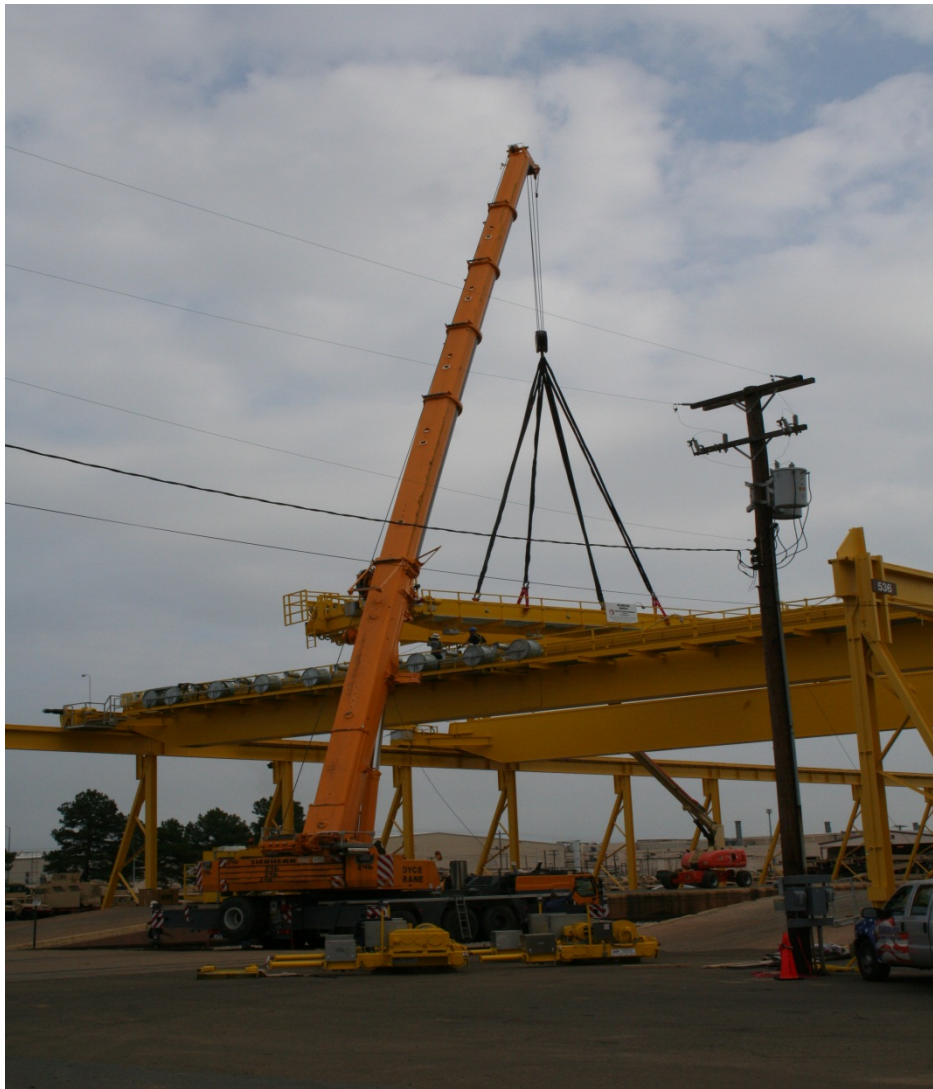
### 75-TON, TOP RUNNING, DOUBLE GIRDER, CAB OPERATED BRIDGE CRANE

***T***he Navy Crane Center accepted one 75-ton rated capacity, top running, double girder, cab operated crane. Unique features of this crane are two bridges, a primary and a secondary, and two 37.5-ton trolleys. The primary bridge spans an incoming railway while the secondary bridge aligns with the rail cars allowing the trolleys to operate in tandem to load and unload rail cars more efficiently. The electric powered crane has a 126-foot primary bridge span and a maximum hook height of 30 feet above the railway. The project also included new runway electrification, removal of the existing 60-ton crane, realignment of the crane runway rail, and reconditioning of the runway support structure.

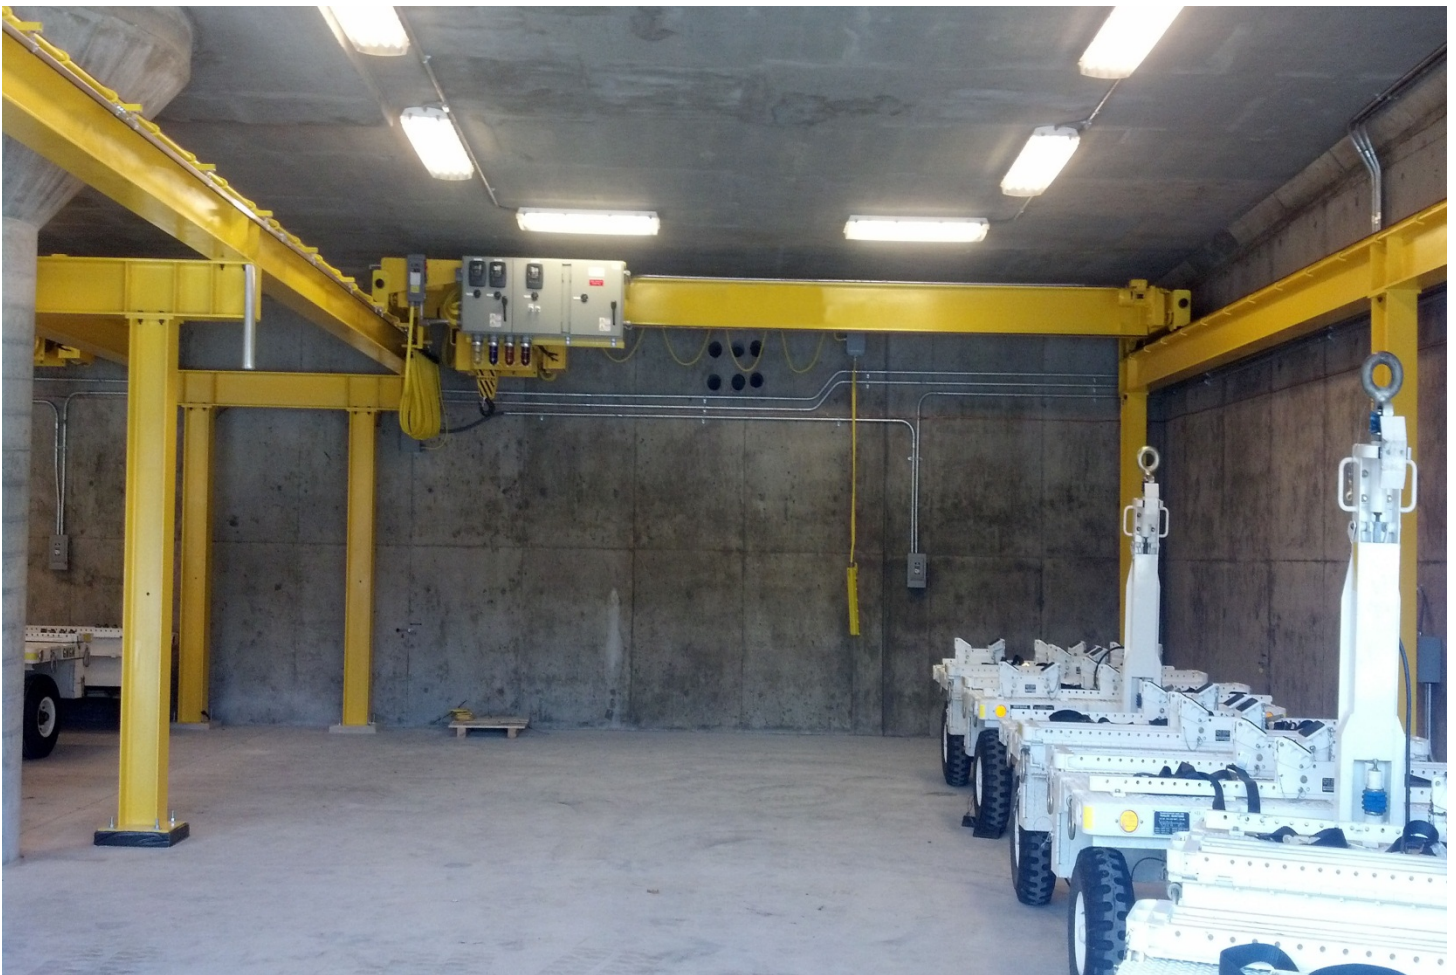
### THREE 4.5-TON, TOP RUNNING BRIDGE, UNDERHUNG TROLLEY CRANES

*The* Navy Crane Center accepted three 4.5-ton rated capacity, top running bridge, underhung trolley cranes. Each crane will serve one of the three storage bays in the structure. The electric powered pendant controlled cranes have spans of approximately 23 feet and a maximum hook height of 9 feet 8-5/8 inches above the finished floor. These cranes were designed to meet the stringent structural loading and clearance requirements of the structure. The crane supporting structure was designed to allow utilization of floor space to the maximum extent possible. Variable frequency drives enable operating speeds from 14 feet per minute down to 1 foot per minute for the hoist, 50 feet per minute down to 2 feet per minute for the bridge travel, and 30 feet per minute down to 2 feet per minute for the trolley travel. The project included the crane supporting structure and runway electrification. ■

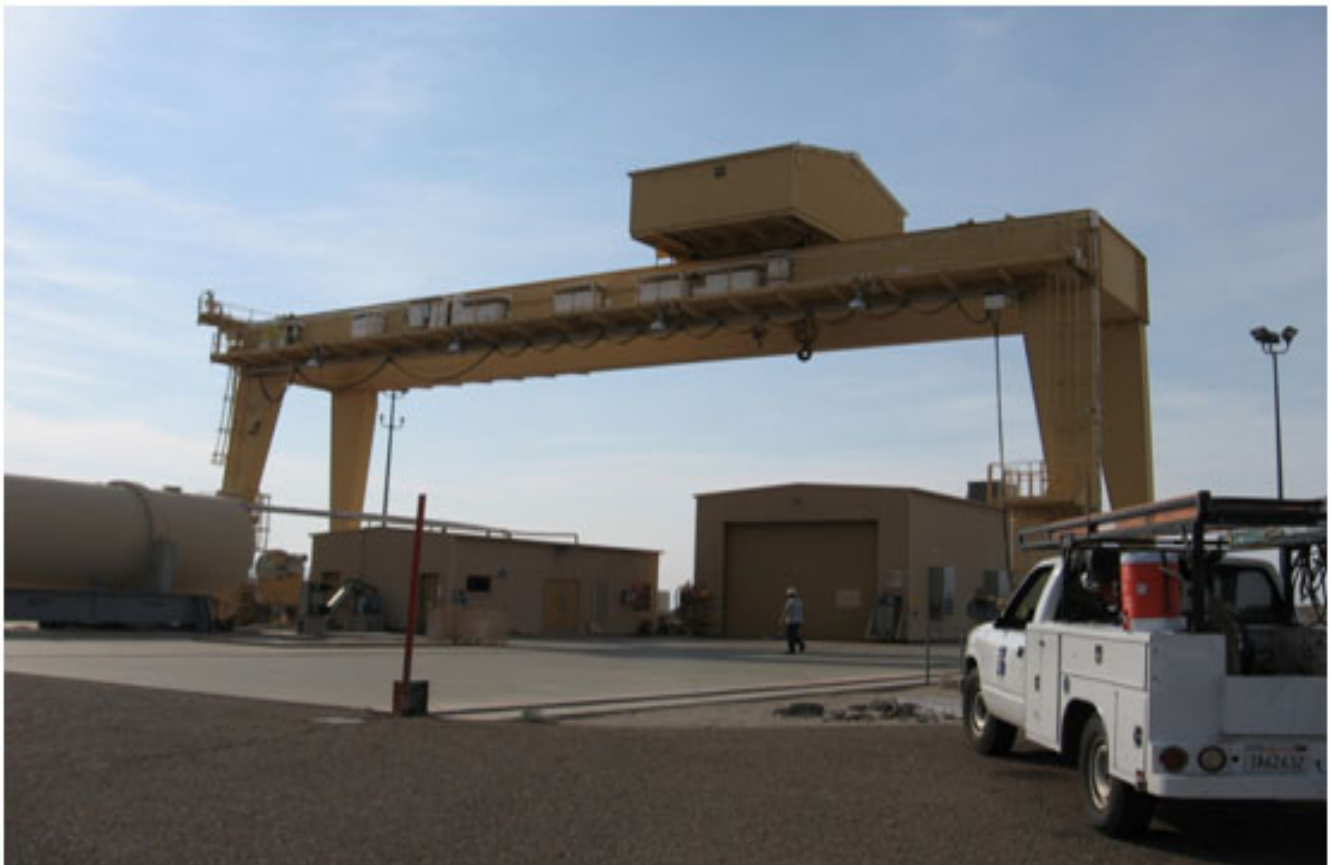
## 65/6-TON GANTRY CRANE OVERHAUL

***T***he Navy Crane Center accepted the overhaul of a 65-ton main/6-ton auxiliary rated capacity ordnance handling gantry crane. The overhaul consisted of full replacement of the hoist/trolley, crane electrification, control drives, and control panels. The electric powered crane has a 100-foot span and a maximum hook height of 132 feet. Closed loop flux vector drives enable operating speeds of 8 feet per minute down to 1 foot per minute for the hoist, 50 feet per minute down to 2 feet per minute for the bridge travel, and 35 feet per minute down to 1 foot per minute for the trolley travel. The overhaul was performed without removing the crane structure from its runway. ■

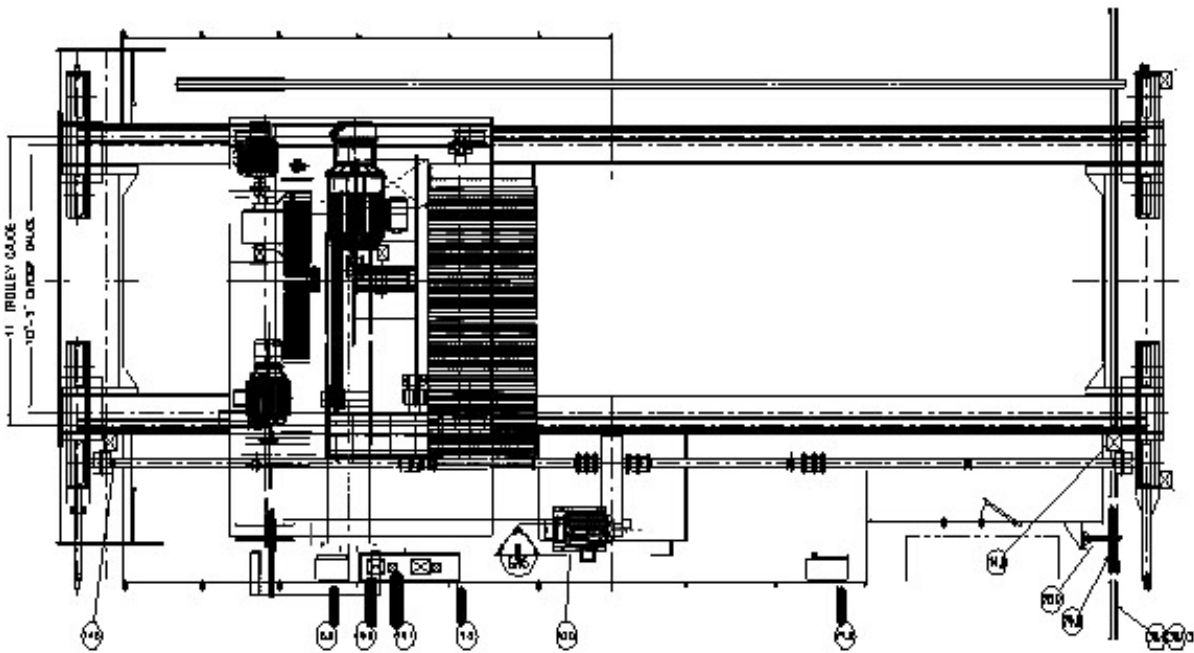
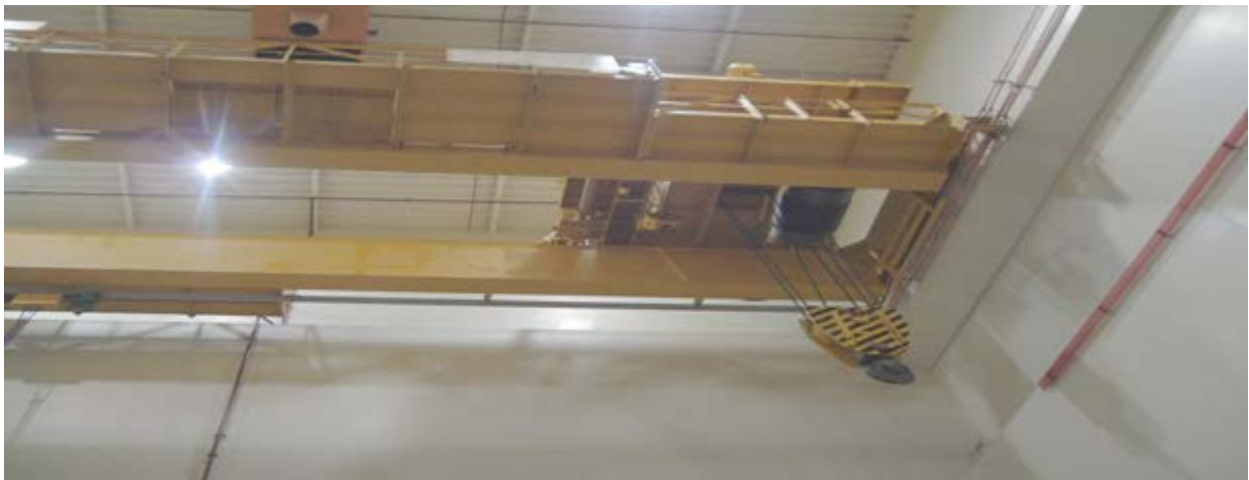
## 65/6-TON BRIDGE CRANE OVERHAUL

**T**he Navy Crane Center accepted the overhaul of a 65-ton main/6-ton auxiliary rated capacity ordnance handling bridge crane. The overhaul consisted of full replacement of the hoist/trolley, crane electrification, control drives, and control panels. The electric powered crane has a span of 53 feet 6 inches and a maximum hook height of 87 feet. Closed loop flux vector drives enable operating speeds of 8 feet per minute down to 1 foot per minute for the hoist, 50 feet per minute down to 2 feet per minute for the bridge travel, and 35 feet per minute down to 1 foot per minute for the trolley travel. The overhaul was performed without removing the crane from its runway.

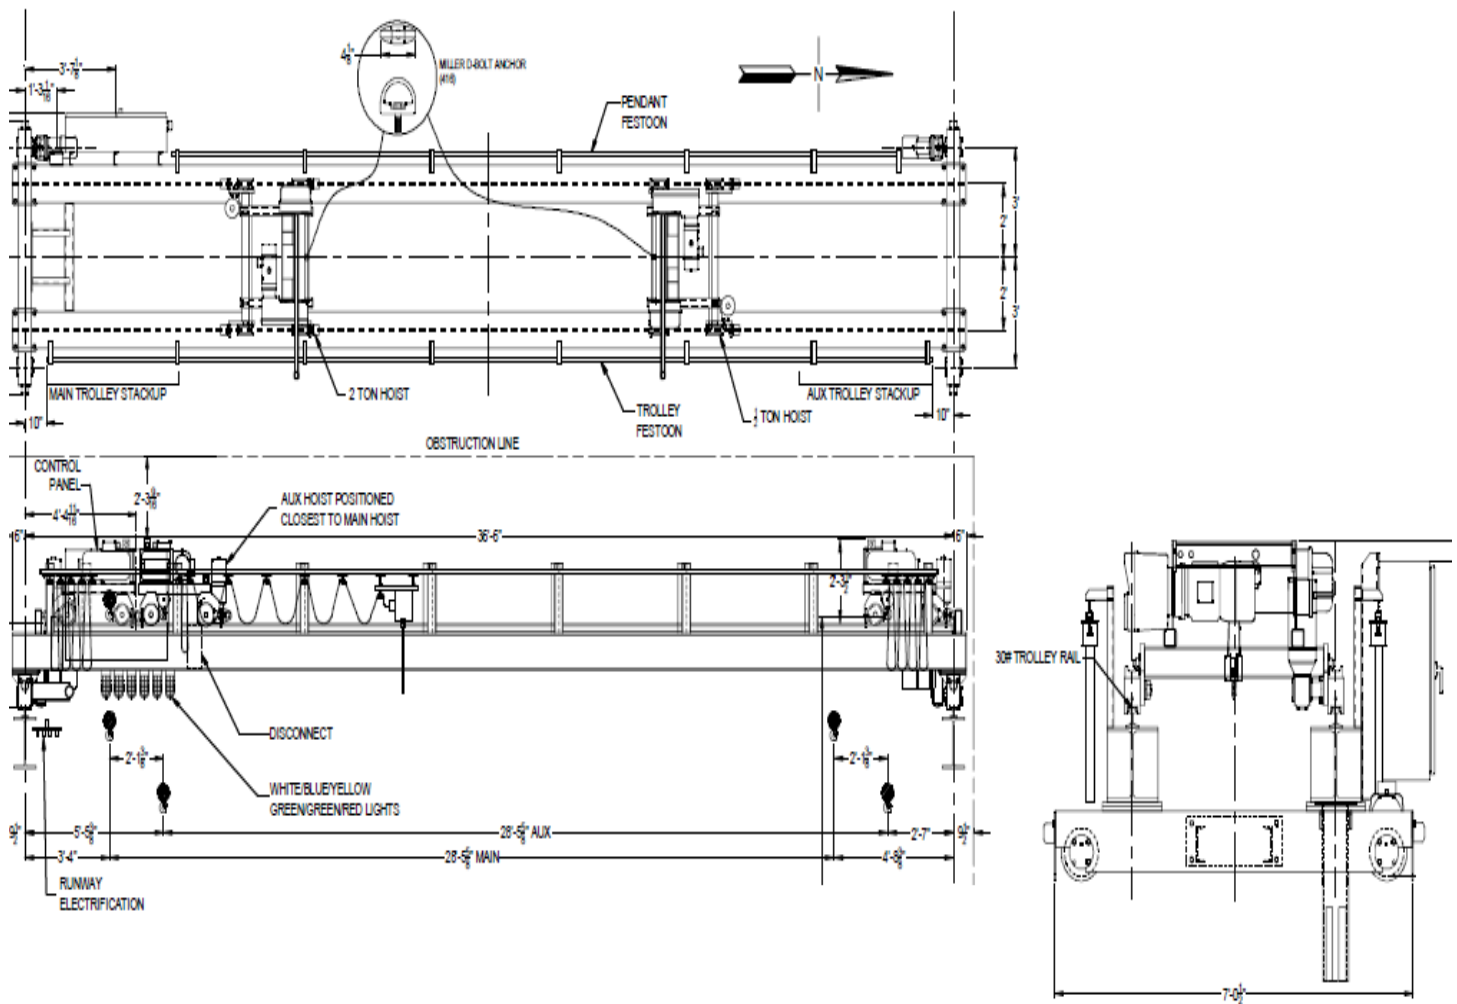
## 2-TON and 3-TON TOP RUNNING DOUBLE GIRDER BRIDGE CRANES

The Navy Crane Center accepted two pendant controlled top running, double girder, ordnance handling bridge cranes. Both of the cranes were contracted to meet the requirements of an existing facility which had a low crane rail compared to the required hook height. The cranes were designed to maximize lift height with the low crane rail. The project included new runway electrification for both cranes. One of the cranes is a 2-ton crane with a ½-ton hoist on a separate trolley that gives the crane the flexibility to upright objects using the hoists in combination. The 2-ton rated capacity crane has a span of 36.5 feet and a hook height of 15.5 feet. The second crane is a 3-ton rated capacity crane, which is designed to go outside over a partially enclosed loading bay. The 3-ton crane has a span of approximately 27 feet and a hook height of 15.5 feet. Variable speed drives on both cranes enable bridge speeds between 5 and 75 feet per minute, trolley speeds between 3.5 and 50 feet per minute, and hoist speeds between 1 and 15 feet per minute. ■

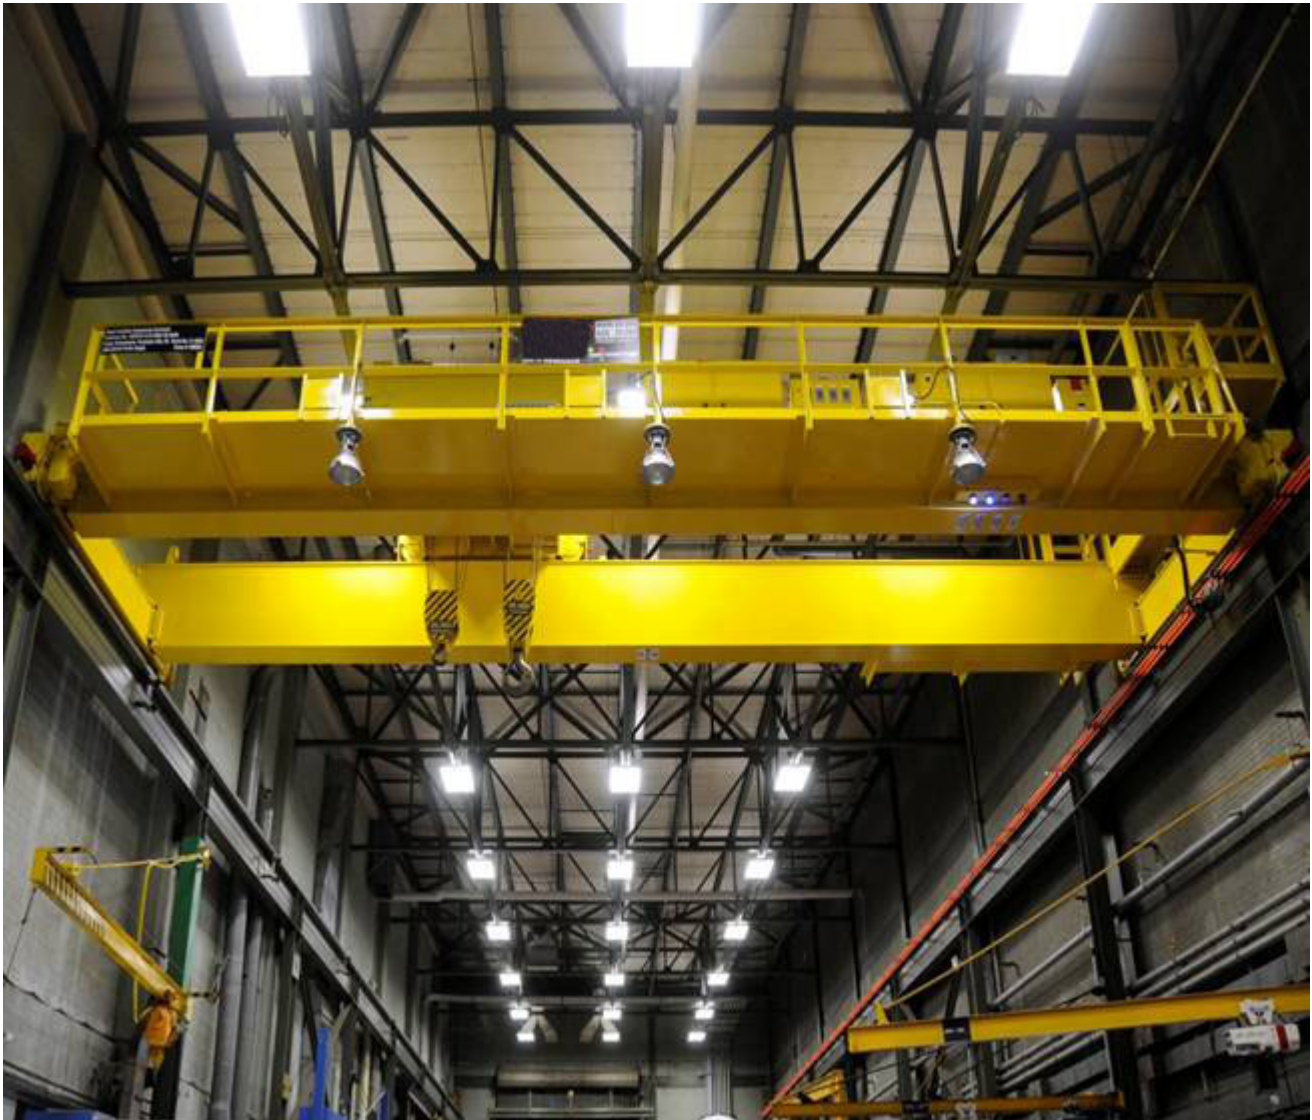
### 30/10-TON TOP RUNNING DOUBLE GIRDER BRIDGE CRANE

**T**he Navy Crane Center accepted a top running double girder crane for an electrical fabrication and repair shop. The electric powered crane has a span of approximately 44 feet and a maximum hook height of 27 feet above the finished floor and includes a radio control option. Variable frequency drives enable operating speeds of 20 feet per minute down to 2 foot per minute for the hoist, 150 feet per minute down to 15 feet per minute for the bridge travel, and 80 feet per minute down to 8 feet per minute for the trolley travel. This crane also has a remote readable load indicating device and new runway electrification.
