# THE CRANE CORNER

## *Navy Crane Center Technical Bulletin*

86th Edition – June 2015

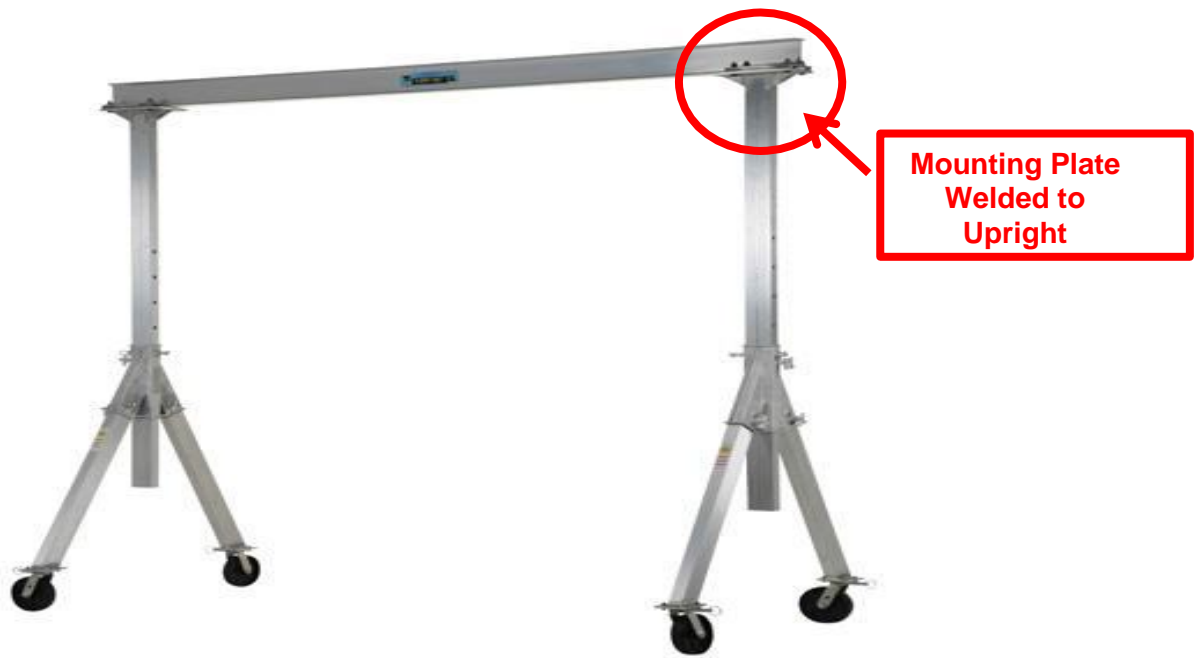
Vestil AHA Gantry with Welded Uprights

B. The original equipment manufacturer (OEM), Vestil Manufacturing maintains these cracks form when the casting is subjected to stresses caused by traveling the crane while loaded, which is prohibited by the OEM operating instructions. During 2014, the OEM modified the design of these cranes by eliminating the bracket and welding a mounting plate with reinforcing gussets to the upright.

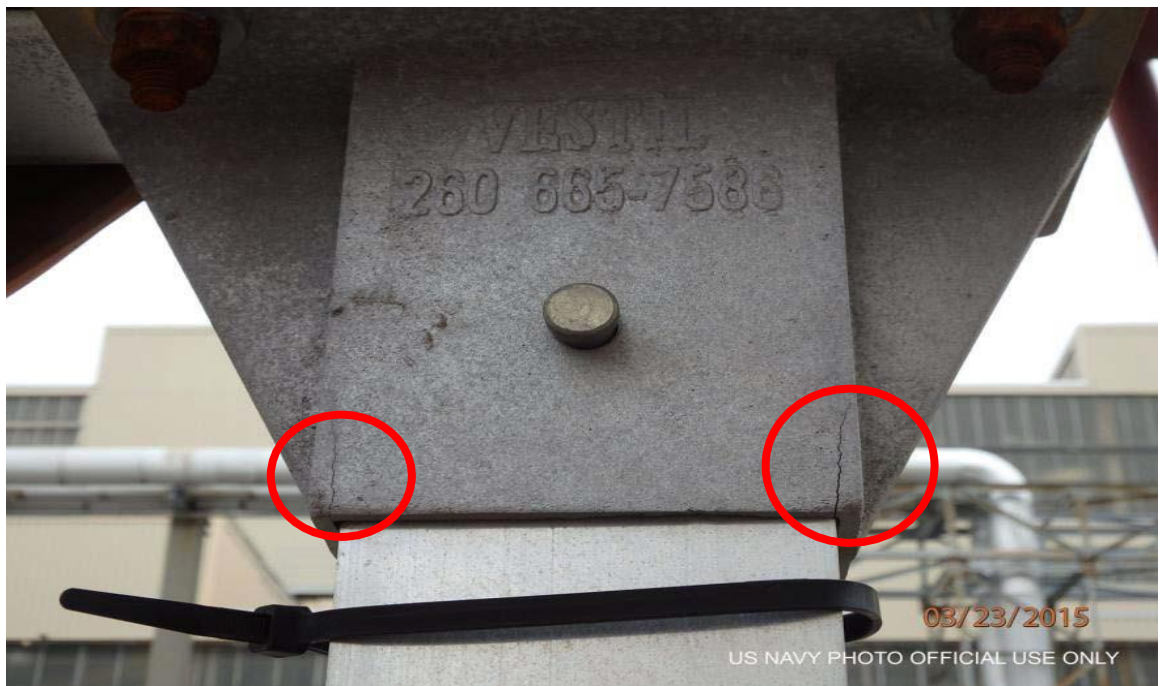
Cracks in Cast Upper Mounting Brackets

A. Within the next 30 days, activities shall inspect Vestil AHA Model Portable Gantry Cranes of all heights and spans that were manufactured with a cast aluminum bracket connecting the girder to the uprights for cracks in the cast aluminum bracket. This includes Vestil models AHA-2 (1-ton), AHA-4 (2-ton), AHA-15 (1500-pound), and could also include other custom models manufactured by Vestil. Activities shall also inspect the aluminum cast Y bracket connecting the legs to the upright assemblies. Any cranes found to have cracks shall be removed from service.

B. Activities finding cracks in the bracket shall either discard the equipment or replace the brackets and uprights with OEM manufactured replacements. The replacement parts feature welded construction and are available only as pairs of uprights. These parts are not warranty replacements.

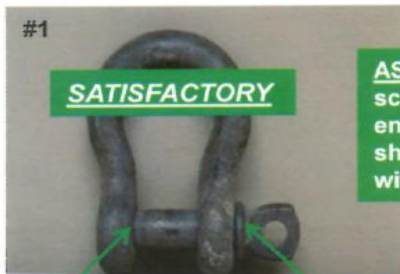
**SATISFACTORY**

**ASME B30.26-1.9.4 (a):** The screw pin shall be fully engaged and tight, and the shoulder should be in contact with the shackle body.

Fully Engaged    Shoulder Contact (Tight)

**PRE-USE INSPECTION OF SHACKLES:** Screw pin shall be fully engaged and tight and the shoulder in contact with the shackle body. (picture #1)

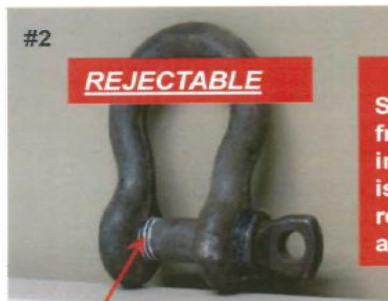
**REJECTABLE**

**ASME B30.26-1.8.4 (g):** Shackles shall be removed from service if damage such as incomplete thread engagement is visible and shall only be returned to service when approved by a qualified person.

Incomplete Thread Engagement

Incomplete thread engagement or inability to seat the shoulder may indicate a bent shackle bow, incorrect pin-to-shackle match, or some other defect. Stop! Remove the gear from service.

**RESULT OF WEAK PRE-USE INSPECTION:** Damaged or loose shackle pins can back out and present the potential for damage to synthetic slings and webbing lashing due to contact with sharp shackle pin threads when the load is lifted. Failure of the rigging configuration can damage equipment or injure personnel. (picture #2)

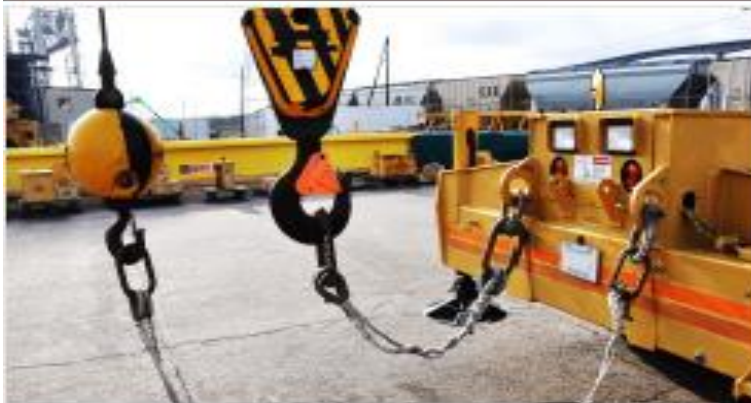
When moving a truck, cruiser or crawler crane from job sites, be sure the hook and block are properly secured to the crane's carrier frame to reduce the chances of equipment damage or personnel injury from a free-swinging hook block. The following is provided for the consideration and use of tie-backs...

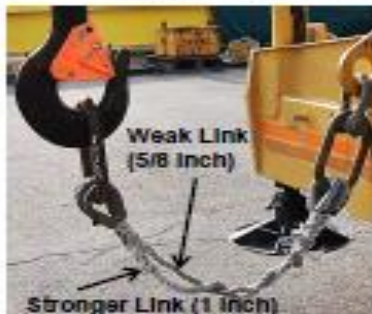
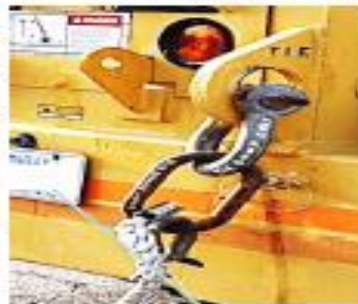
- A weak-link connection shall be used to secure the hook block to the crane. The breaking strength of the connecting piece shall be less than the rated load of the hook block's wire rope as reeved. This allows the tie-back to act as the weak-link and break before any additional strain is placed on the equipment.
- When securing the hook block, raise it just enough to take up the slack. Do not over tighten.
- Ensure there are adequate clearances.
- Tie-back gear does not have to be certified. Each piece of tie-back gear, including OEM padeyes, should be marked "tie-back only" to minimize the potential of getting mixed up with certified rigging gear.
- When securing the hook blocks for highway travel, add a back up (stronger) tie-back to prevent free swinging in the event of weak link failure.

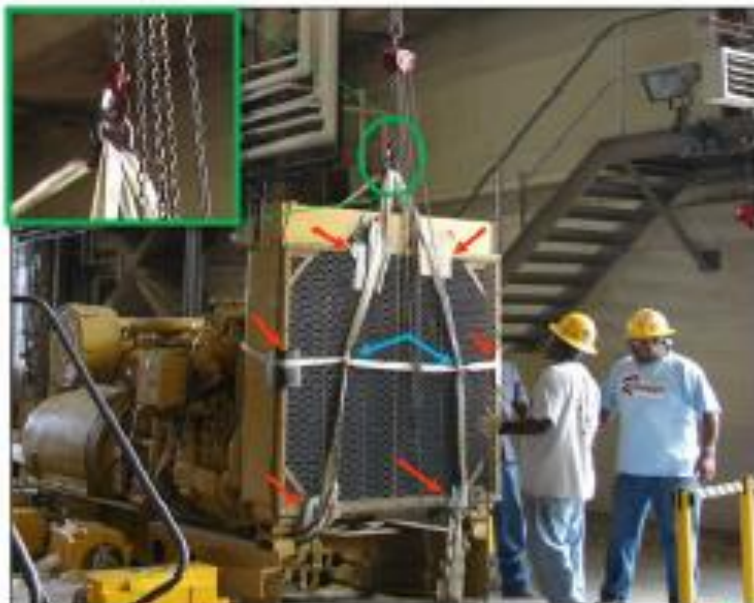
*In this picture, synthetic (nylon) lashing is used to rig the load and to create the lift point to which the chainfall is attached. Clove hitches are tied on each vertical-horizontal intersection to help maintain positioning and configuration. Approved chafing material is used to protect the synthetic lashing from damage (cutting, tearing, breaking). Ensure your hook or shackle is large enough to properly seat all the parts of lashing in a safe manner (avoid overcrowding).*
