THE CRANE CORNER

Navy Crane Center Technical Bulletin

58th Edition – June 2008

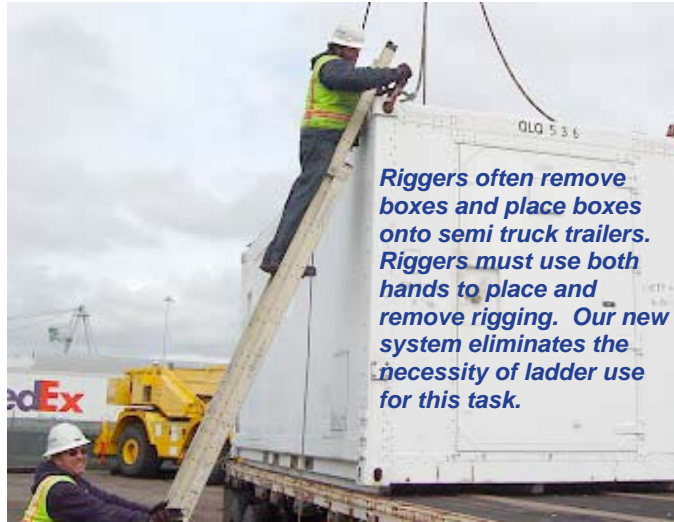
OLD METHOD

Riggers often remove boxes and place boxes onto semi truck trailers. Riggers must use both hands to place and remove rigging. Our new system eliminates the necessity of ladder use for this task.

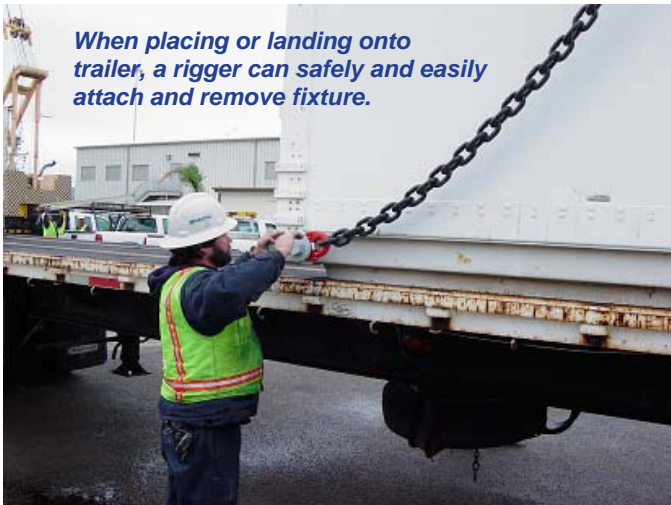
NEW METHOD

When placing or landing onto trailer, a rigger can safely and easily attach and remove fixture.

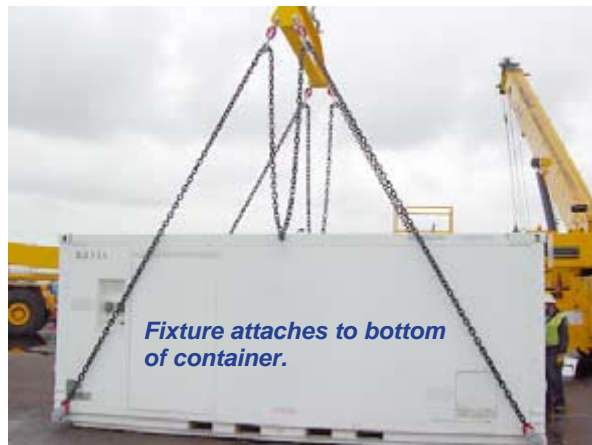
Fixture attaches to bottom of container.
