# THE CRANE CORNER

## *Navy Crane Center Technical Bulletin*

69th Edition – March 2011

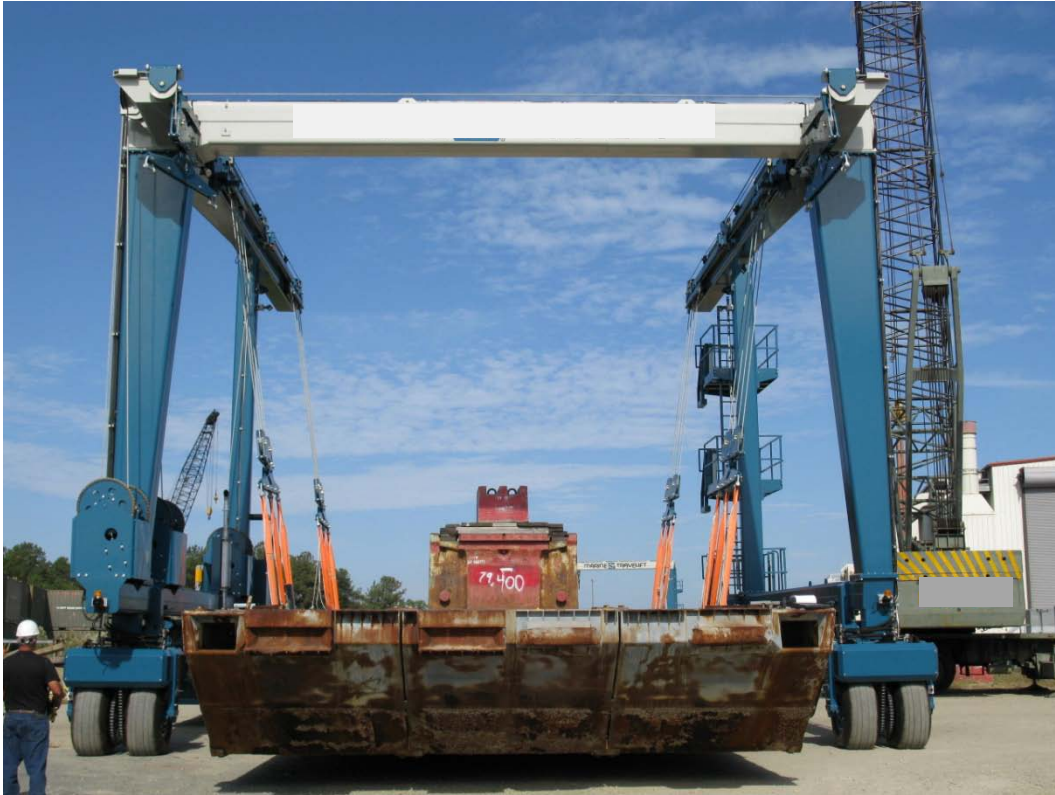
**T**he Navy Crane Center Acquisition Department recently inspected and oversaw acceptance testing of a new 250-metric ton rated capacity mobile boat hoist (MBH). The contract acceptance inspection and test were used by the activity as the inspection and load test for crane certification. The MBH has an inside clear width of 51-feet, a clear height of 32-feet, a 41-foot 6-inch wheel base and has pick and carry capability at its full rated capacity at a speed of 65-feet per minute. ■

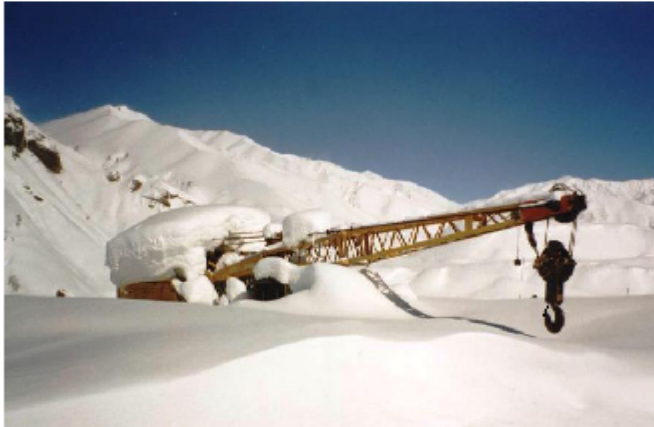
Title: CRANE OPERATIONS IN FREEZING TEMPERATURES

**Freezing temperatures, snow, and ice** can create unique **hazards** in weight handling operations. **Be vigilant** in recognizing and reacting to these potential hazards:

- **Tracks, sheaves, hoist blocks** or other crane components can **become iced up or frozen** which can cause equipment damage.
- **Dislodged /Falling ice hazards** may exist from suspended loads, rigging or crane components.
- **Ice on crane platforms or ladders and rail systems** can create **slip/fall hazards**. Similar hazards may exist throughout the weight handling operating envelope.

- **Exercise increased care and diligence** during pre-use inspections. Frozen or damaged components can increase risks to equipment and personnel. **Focus on potential ice hazards** as the boom, block, sheaves and wire rope can become frozen, increasing the chance of creating damage. Always **raise the hoists** prior to lowering during the pre-use operational check.

- **Practice ORM. Eliminate hazardous walking/working surfaces** when possible. Ensure visibility is not obstructed by ice or snow build-up.
- Prior to lifting a load, **remove excess ice or snow from the load** that may create an additional hazard during movement. Maintain a clear operating envelope to decrease potential of being struck by falling ice.

- **Adjust your operating pace** so that it is conducive to the weather conditions and the ground crew's ability to stay safely engaged.
- **Be aware** that **loads** are likely to be **frozen to the ground or structure**.

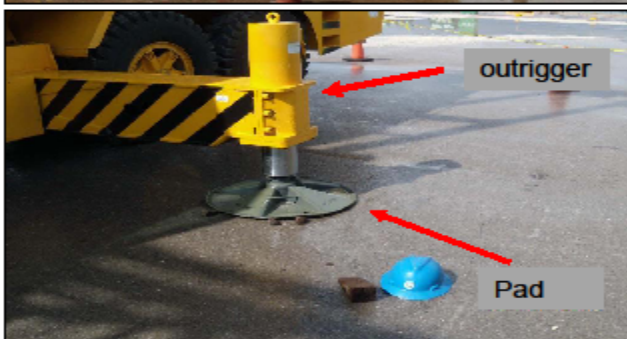
Accident location

outrigger

Pad

- Failure to avoid the pinch-point hazard.

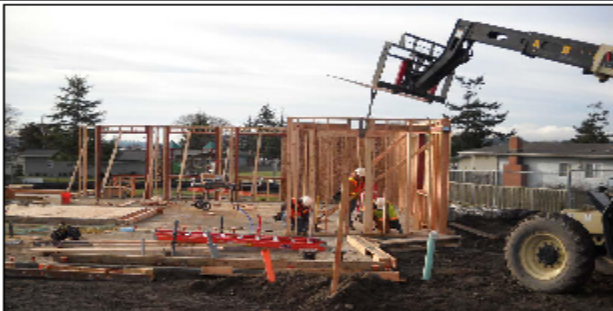
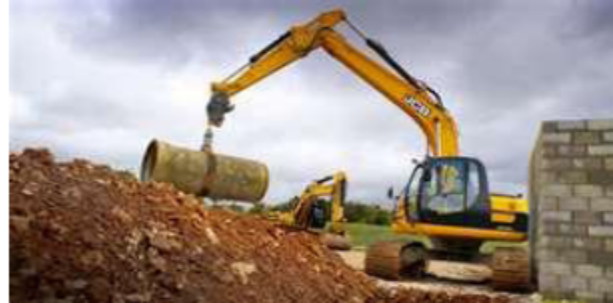
**Title:** Lifting Suspended Loads with "Non-Crane" Equipment  
**Target Audience:** Operators of Non-Crane Equipment being used to Suspend Loads

- Performing suspended load lifts with multi-purpose machines, forklifts, or construction equipment is very convenient; and can be very dangerous if not performed 'by the book!'

- NAVFAC P-307 OF DECEMBER 2009, SECTION 10, paragraph 10.18
  - Ensure the equipment OEM permits such lifts to be made.
  - Ensure equipment is configured as required by OEM.

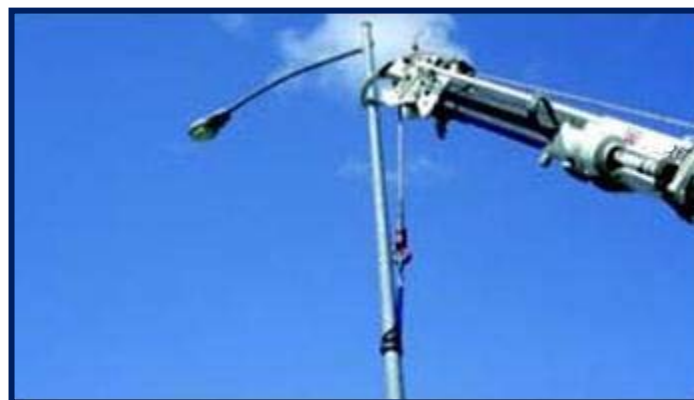
NAVFAC Southwest recently purchased an innovative sling that offers improved friction for gripping power poles of various materials. The light pole handling sling was developed and application tested by a utility company who wanted a sling protection material that also provides superior gripping properties. The company performed lifts in various conditions to ensure the sling performed satisfactorily.

The sling may be used in applications where additional gripping power is needed. However, users must evaluate all conditions to ensure proper sling performance. Poles and other objects will handle differently depending on shape, material composition, and condition (wet, dry, frozen, slippery, etc). The pole must be double wrapped and choked with a sling of sufficient length. ■
