THE CRANE CORNER

Navy Crane Center Technical Bulletin

71st Edition – September 2011

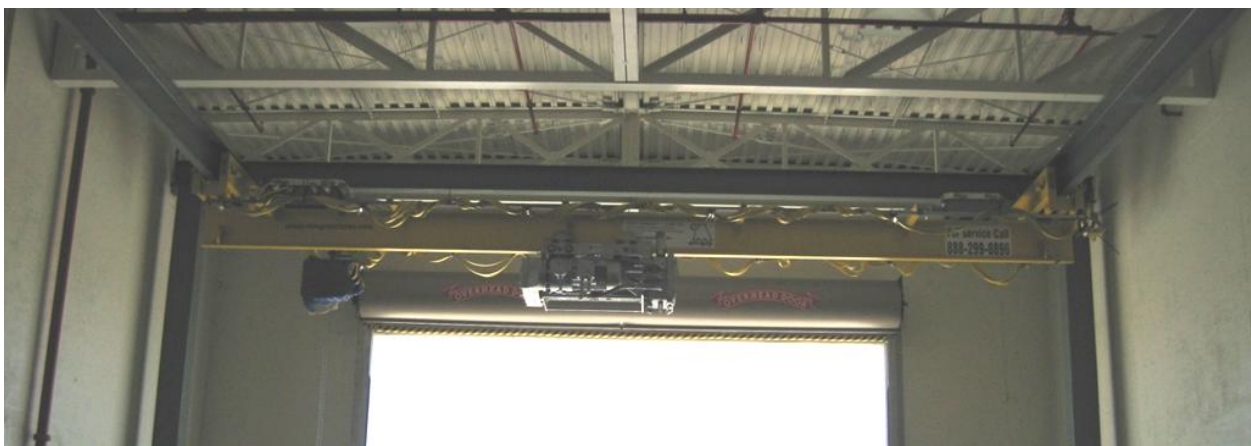
3-ton Ordnance Handling OET Crane on Free-Standing Runway

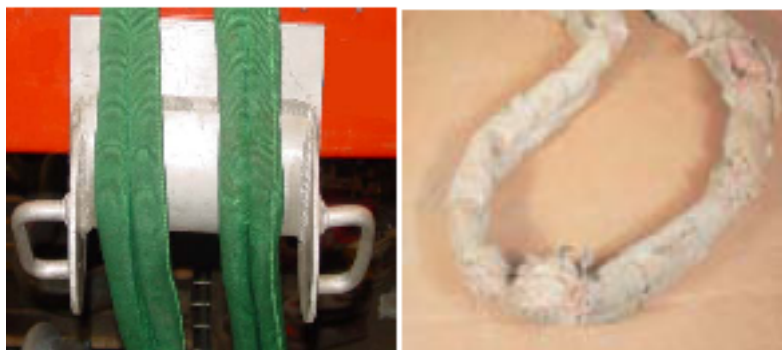
Thus far In FY11, *10 damaged synthetic sling accidents have been reported where improper, inadequate, or no chafing material was used. Two accidents resulted in dropped loads.* Synthetic slings provide a much greater ease of handling when compared to wire rope or chain slings, but they are also very susceptible to damage and can be easily cut if used improperly. If synthetic slings are used improperly, or inadequate/improper chafing material is used, the consequences can be disastrous! Listed to the right are several synthetic sling use requirements and considerations:

- Use synthetic slings **per** the **OEM** and **ASME B30.9** requirements.
 - **Chafing protection must be used** where there is a possibility of slings being cut or otherwise damaged due to **sharp edges**, or configurations that could cause damage. Chafing protection material **shall be** of **sufficient thickness and strength** to prevent sling damage.

- **Ensure the rigging configuration is stable** and **SLINGS CANNOT SLIDE OFF THE CHAFING** protection material.
 - **Ensure sling capacities are adequate** in the configuration used and consider the effects of sling angle stress when slings are used at angles other than vertical.

- **Recognize** that the edge need not be "razor" sharp to damage and cut the slings. **Compression** and **tension**, combined with a "moderate" edge and the **sling skipping** across the load edge, **can result in sling damage**.

- Remember, **SYNTHETIC SLINGS ARE UNFORGIVING IF USED IMPROPERLY!** Follow OEM requirements, and always use adequate chafing material to protect the rigging and load when rigging gear is subjected to hazards. Wear protection devices should be selected for the specific conditions of the lift!
