THE CRANE CORNER

Jun 2020
106th Edition

Navy Crane Center Technical Bulletin

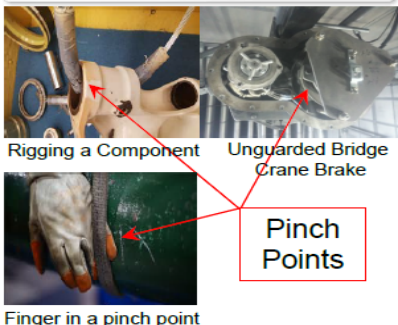
Pinch Point is defined as, "any point at which it is possible for a person or part of a person's body to be caught between a moving and stationary object(s)."

Over the past few months, several weight handling accidents and near misses have been reported that involved employees placing their hands in a pinch point, one of which **resulted in a significant injury**. A historical review of reported injuries identified that the majority of injuries occur to the hand and fingers. Examples of "pinch point" related hand injuries and how they can be minimized is discussed below:

- Specific pinch point hazards, locations (e.g., where in the process), and mitigating actions should be discussed at all pre-job briefs. **Simply stating that pinch points exist is not sufficient**. Briefs should stress to individuals to be careful with regard to where they are placing their hands. Supervisors should stress the importance of using gloves to minimize the potential for injury. Lastly, always remember that if an operation cannot be completed without placing your hand in a pinch point, stop and notify your supervisor.
