# THE CRANE CORNER

## *Navy Crane Center Technical Bulletin*

67th Edition – September 2010

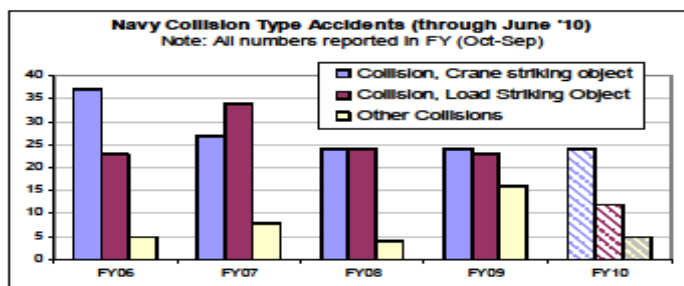
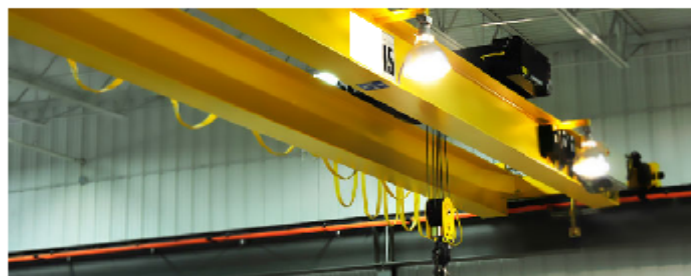
Title: Collision Type Accidents

- 39% of all crane accidents reported in FY10 have been collision related accidents. Crane collision accidents (cranes striking objects) reported through June are already equal to all of the crane collisions in FY09!

- Bridge Crane collisions are 27% greater than the equivalent FY09 reporting period (Oct-June) and represent more than 1/3 of all of the reported collisions thus far in FY10.

- Causes have been attributed mostly to operator error. However, contributing factors include not employing energy control procedures (LO/TO) when personnel were performing work in the operating envelope, inadequate clean up following maintenance, and improper placement of materials that increased congestion in the travel path.
