THE CRANE CORNER

Navy Crane Center Technical Bulletin

85th Edition – March 2015

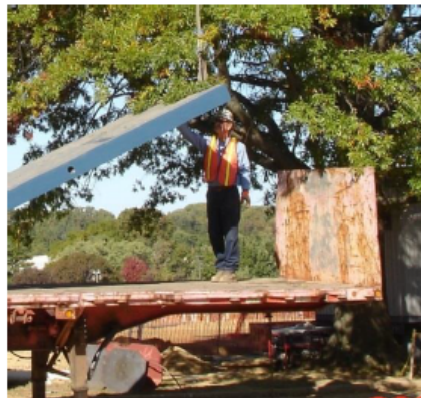
Crane Rigger positioned himself in a "**pinch point**" as he signaled the crane to up-right a 20,000 pound tower crane counter weight. If the weight slid toward him he would be crushed.

****Signal the crane from the ground, if the load does slide no one will be injured.**

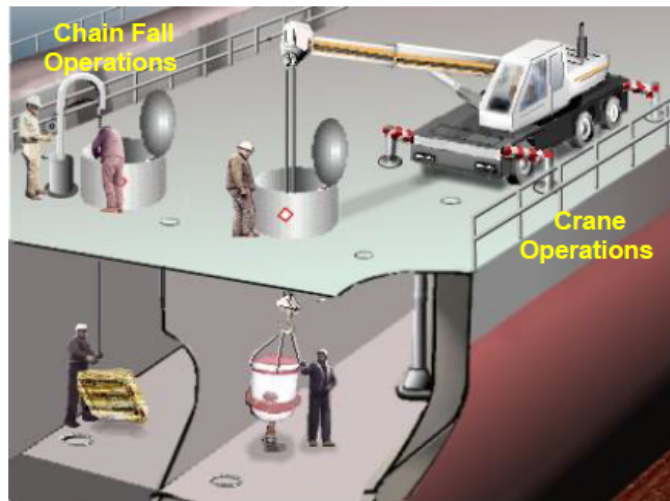
Accident metrics have identified a negative trend involving rigging gear that was being hoisted from confined or enclosed areas and getting snagged on structure. During these events, the crane was normally hoisting with only the rigging gear on the hook.

Notify your supervisor immediately of any intrusions, e.g., ventilation hoses, electrical cables, ship's structure or utilities, into your path or rigging path that can not be mitigated. Maintain a high level of awareness for any intrusions that may appear during the lift evolution.

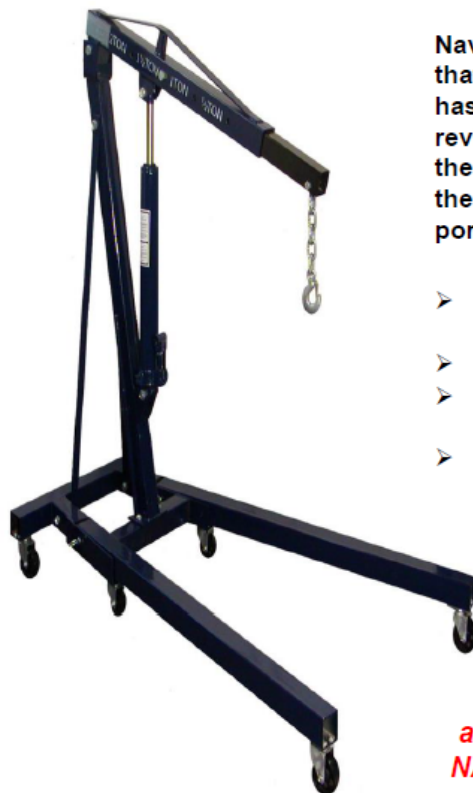
Navy Crane Center continues to receive reports of structural failures of portable floor cranes that do not meet the required safety standards. The required standard for portable floor cranes has recently changed as the *ASME Portable Automotive Lifting Devices (PALD)* has been revised to the *Portable Automotive Service Equipment (PASE) 2014*. Activities shall ensure that the ASME PASE 2014 is utilized in procurements and ensure that the equipment received meets the standard. Following are some of the requirements that must be followed by activities for portable floor cranes:

Activities shall ensure that they procure and use portable floor/shop cranes in accordance with ASME PASE or ASME PALD, manufacturer's recommendations, and NAVFAC P-307. Activities shall also ensure that they test portable floor/shop cranes in accordance with NAVFAC P-307.
