THE CRANE CORNER

Navy Crane Center Technical Bulletin

78th Edition – June 2013

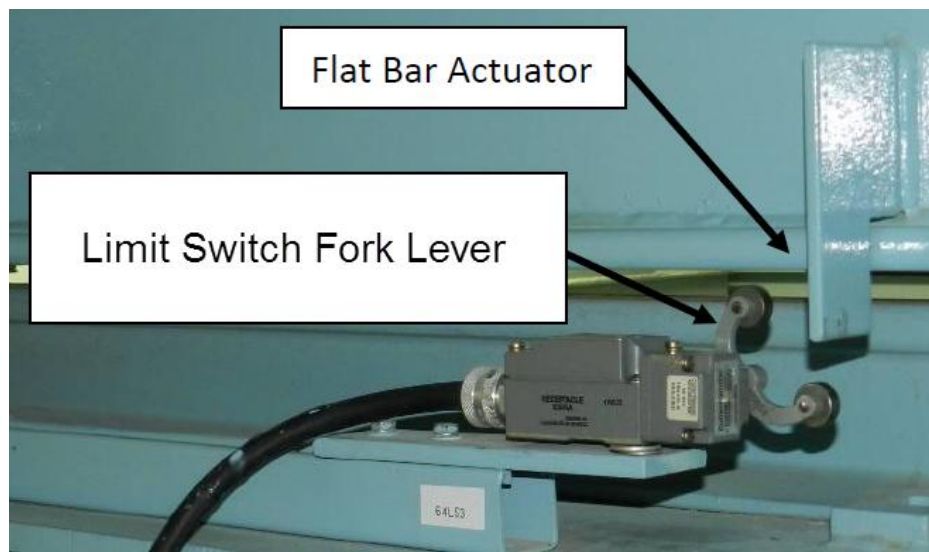
A private shipyard that uses a mechanical fork-style limit switch that prompts the bridge travel of a crane to switch to slow speed when the limit switch is actuated. The switch is activated when the flat bar actuator located on the bridge makes contact with the stationary limit switch fork lever, activating either a “normal” or “actuated” position. The “actuated” position changes the drive to slow speed.

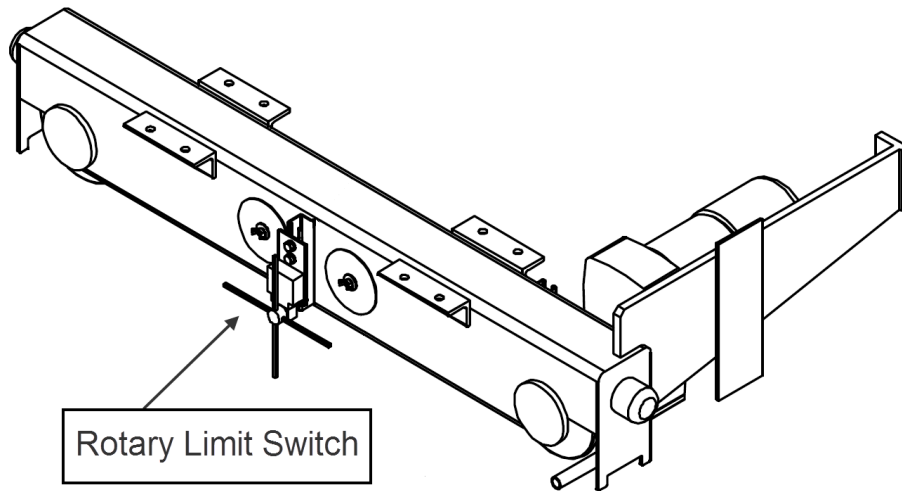
Similarly, at a Navy activity, a limit switch is used to slow the crane as it approaches the end stops. In this case, a rotary limit switch is located on the crane end truck, as shown below, and the actuator is mounted on the crane runway.

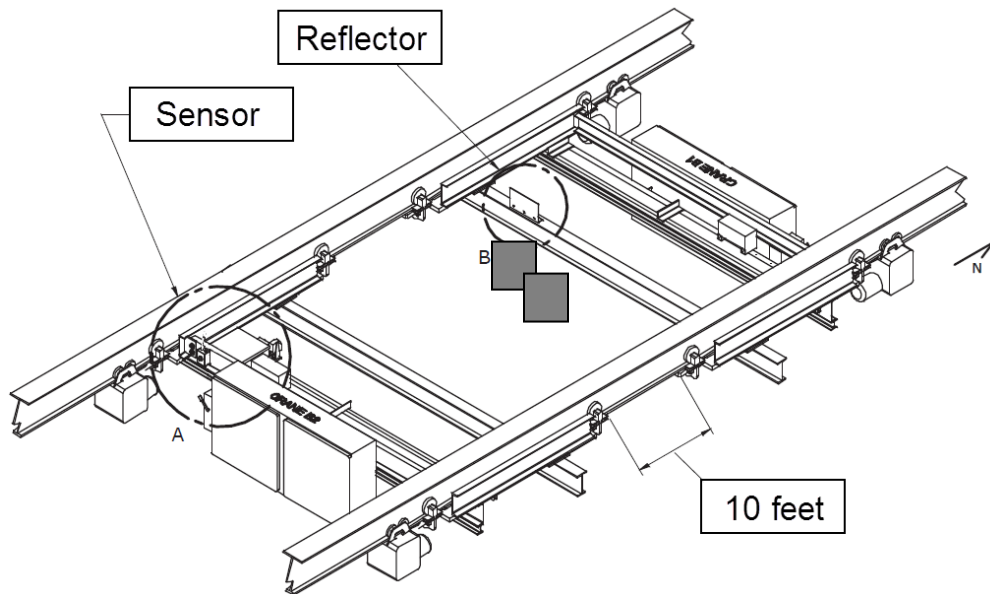
Another Navy activity added an anti-collision alarm system on two cranes that share a runway. A sensor was added on one crane and the reflector on the other. An audible alarm alerts the operator when the cranes reach a set distance apart, in this case 10 feet. The alarm allows the operator to assess the situation and will minimize the risk of unplanned crane contact.

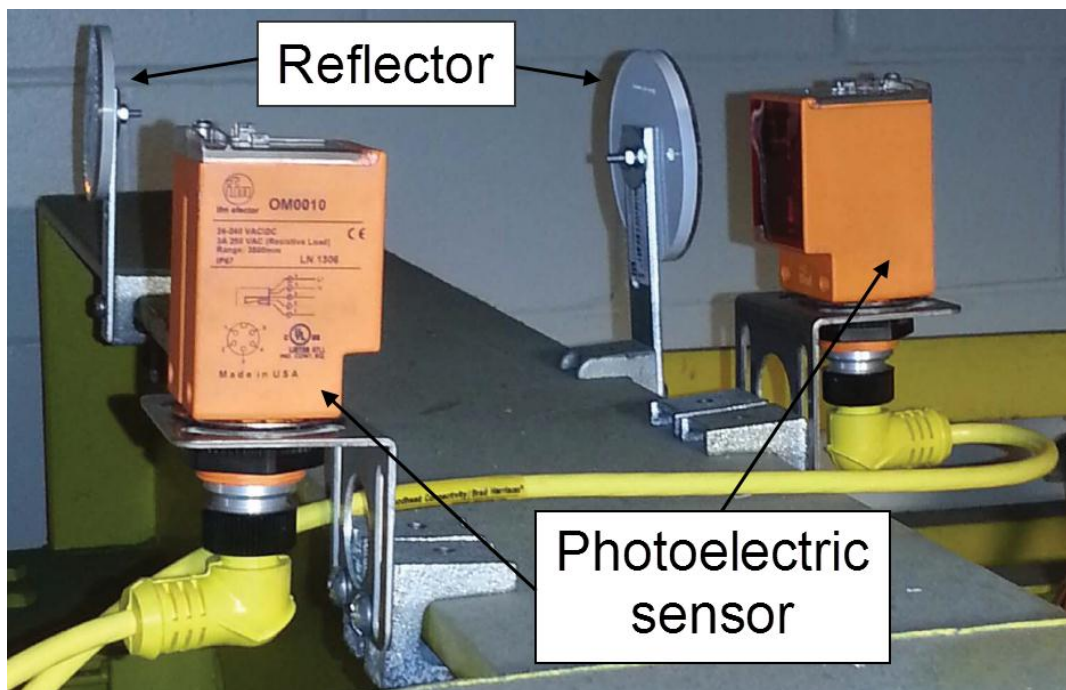
Another Navy activity has a runway with four cranes. Several sets of sensors are installed to maintain a minimum distance of 15 feet between cranes to avoid rail over-loading. A photoelectric sensor is mounted to the top of the bridge beam and the reflector is located on the other crane's bridge beam. The picture below shows one of the interior cranes that has both sensor and reflector. If the cranes come within 15 feet of each other, the travel drives are shut down in that direction to prevent further travel.
