THE CRANE CORNER

Weight Handling Equipment Technical Bulletin
<http://ncc.navfac.navy.mil>

35th EDITION - Web Version
September 2002

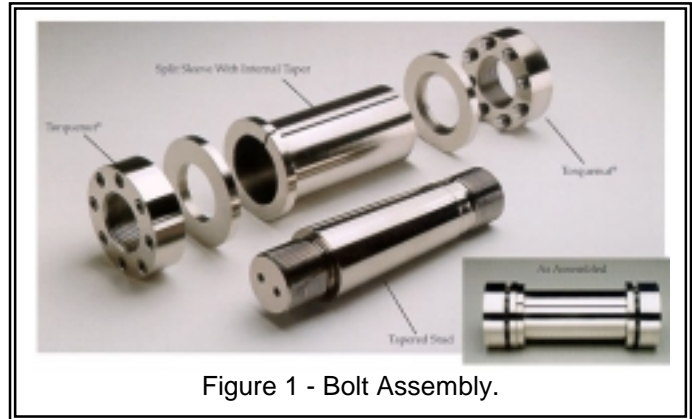
Radially expanding bolt assemblies are available for installation as "body bound" or "interference fitted" bolts, but without the need for precise bolt machining and hole reaming. The bolt assembly is shown in figure 1 and consists of:

- Expandable sleeve (split and internally tapered)
- Tapered stud, threaded on both ends
- Two thrust plates (washers)
- Two multi-jackbolt type nuts, each with a ring of threaded holes and a set of jackbolts

Figure 1 - Bolt Assembly.

The bolt holes of the components to be bolted must be matched drilled. Ideally, the holes should be 0.005 to 0.010-inch oversize, but the expansion bolts can accommodate holes as large as 0.020-inch oversize. Slight variations in hole-to-hole diameters can be accommodated. Expansion bolts can also be used as alignment tools for free shifting components.

Expansion bolt assemblies have been made in various bolting materials and can be adapted to a variety of applications. The nuts may be designed to have the setscrew style jackbolts recessed, as shown in figure 1, or jackbolts protruding for securing with optional lockwire.
