THE CRANE CORNER

Navy Crane Center Technical Bulletin

43rd Edition - September 2004

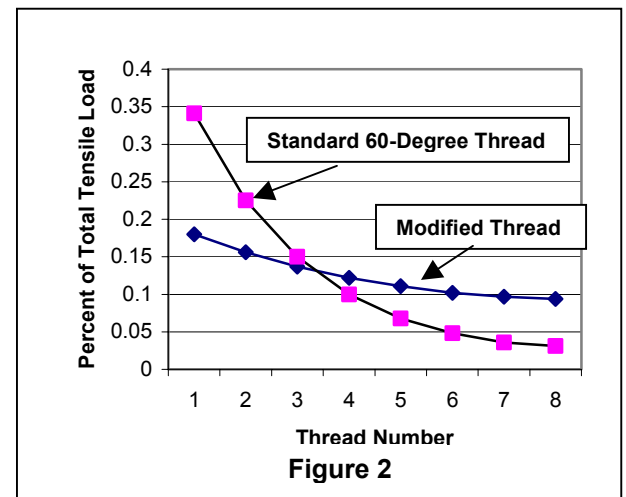
A subtle modification of the standard 60-degree screw thread - introduction of a 30-degree (from thread axis) ramp at the major diameter of the internal thread - yields significant improvements to the quality of the fastener joint. Figure 1 depicts the contact patterns of a fastener in a standard 60-degree and modified internal thread. As can be seen, fastener contact with the modified thread is in the form of a spiral line defined by the fastener thread crest and the ramp - rather than area contact of flanks with the standard threads. The effect of the ramp is two-fold - resistance to loosening and more uniform thread load distribution than is obtained with standard threads. Figure 2 provides a representative comparison between the thread load distribution of the two types of threads.

Fastener resistance to loosening is due to its positive centering in the mating thread (centering eliminates the transverse vibrations that are the primary cause of loosening) and wedge locking of the fastener thread crest with the ramp.

Maximum Stress	Standard 60-Degree Thread	Modified Thread
Tensile	54,300 psi	42,600 psi
Compressive	84,200 psi	89,900 psi
Shear	25,900 psi	13,600 psi
Moment to Cause Relative Rotation	8.9 lb-ft	31.8 lb-ft

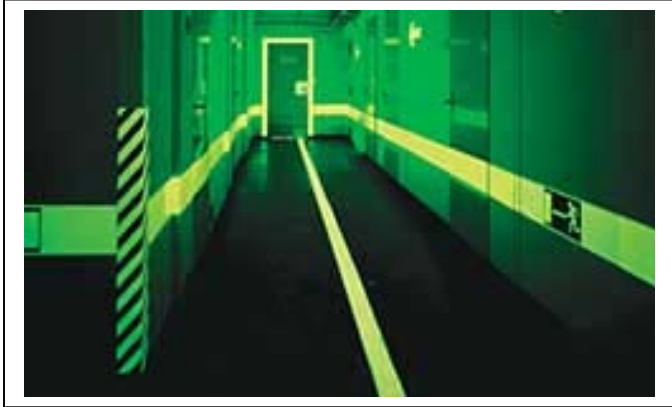
Photoluminescent products are also well suited for applications where the lights can go out suddenly and completely such as on walkways on an overhead electric traveling crane, or in the interior gantry tube of a portal crane where personnel may be working.

Photoluminescent products use either of two materials, zinc sulfide (ZnS) phosphors or strontium aluminate (SrAl) phosphors, which have the ability to accumulate energy from ambient light and generate an afterglow. Like a naturally occurring battery, they store energy and are able to give it off as light. Strontium aluminate products can hold ten times more energy and have a useful life that is three to four times longer than zinc sulfide. While a zinc sulfide product is visible for 1 1/2 to 3 hours, a strontium aluminate product's typical visibility is significantly brighter and lasts up to 8 hours.
