THE CRANE CORNER

Navy Crane Center Technical Bulletin

48th Edition - Web Version - December 2005

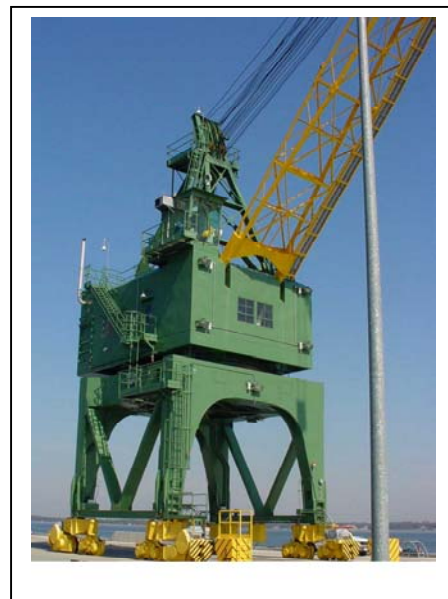
In 2002, most of the crane components were restored. Some of the major modifications were installing electronic static stepless controls for the electric hoist drives, installing electro-mechanical disc brakes for the hoists, reconditioning the main engine generator set including retrofitting with new controls, painting the entire crane, and installing a new jib extension. Navy Crane Center administered the crane modification contract. The following information was taken from the crane's load chart:

<u>Hoist</u>	<u>Capacity</u>	<u>Hook Radius</u>
Main Hoist	56,000-lb	77-ft
	39,390-lb	90-ft
Whip Hoist	16,800-lb	120-ft
	15,680-lb	139-ft
