THE CRANE CORNER

Navy Crane Center Technical Bulletin

52nd Edition – December 2006

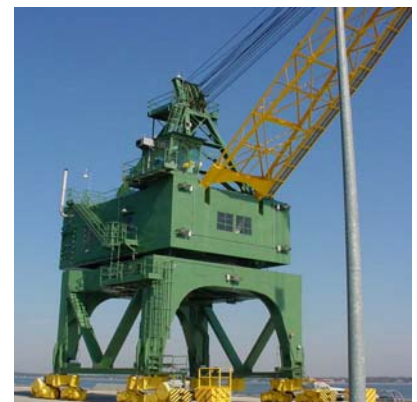
The 25-ton crane (shown on right) is a Lindholm design manufactured by Star Iron in 1963. In 2002, the crane completed an extensive restoration that included installing electronic static stepless controls for hoists drives, installing electro-mechanical disc brakes, reconditioning the main engine generator set, painting the entire crane, and installing a new jib extension. The modifications to the crane were executed under a contract administered by the Navy Crane Center. The following information was taken from the crane's load chart:

<u>Hoist</u>	<u>Capacity</u>	<u>Radius</u>
Main	56,000-lb	77-ft
	39,390-lb	90-ft
Whip	16,800-lb	120-ft
	15,680-lb	139-ft

Naval Munitions Command (NMC) Yorktown no longer has a need for their 25-ton and 40-ton portal cranes. Both cranes are located at the Naval Weapons Stations Yorktown, Virginia. Track gauge for these cranes is 30 ft. Anyone interested in obtaining these cranes should contact Naval Munitions Command Yorktown or NAVFAC Midlant.

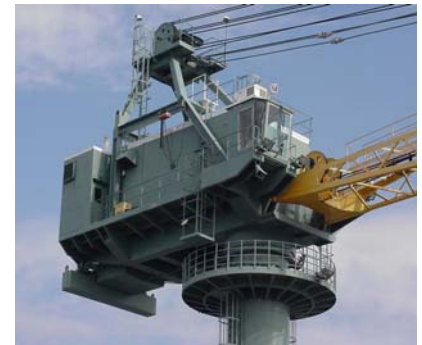
The 40-ton crane (shown on right) was manufactured by Intercontinental in 1992. In 2002, the rotate bearing was replaced and the crane was certified for operation annually until 2006. The following information was taken from the crane's load chart.

<u>Hoist</u>	<u>Capacity</u>	<u>Radius</u>
Main	89,600-lb	95 ft
	76,000-lb	115 ft
	56,000-lb	140 ft
Whip	16,800-lb	182-ft
