THE CRANE CORNER

Navy Crane Center Technical Bulletin

54th Edition – June 2007

Back-up Monitoring System

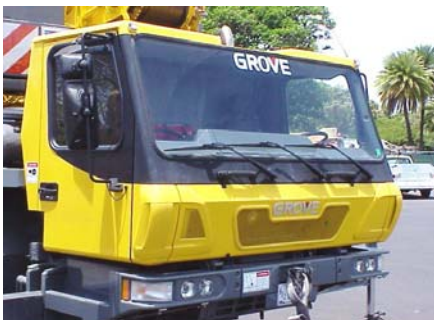
When their new Grove GMK truck cranes arrived, NAVFAC Hawaii noticed that the cranes lacked visibility to the rear other than side mirrors, unlike some of their other truck cranes, which have a cab window to the rear. Deciding to be proactive and avoid a possible incident, they installed a backup monitoring system to one of these cranes for field testing. They are in the process of purchasing four more units for their other GMK truck cranes and are considering installing the system on all of their other truck cranes.

The system consists of a camera with microphone and ultrasonic sensor facing the rear of the crane, and a 7" LCD monitor with speaker mounted in the cab so the operator/driver can hear, see, and confirm what is behind the crane.

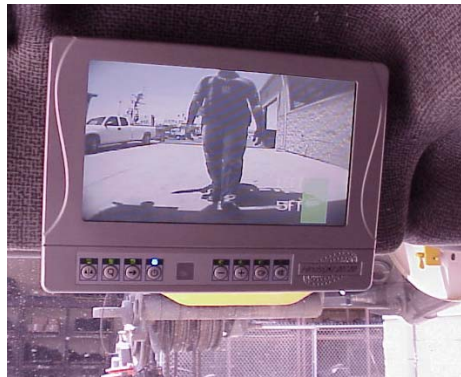
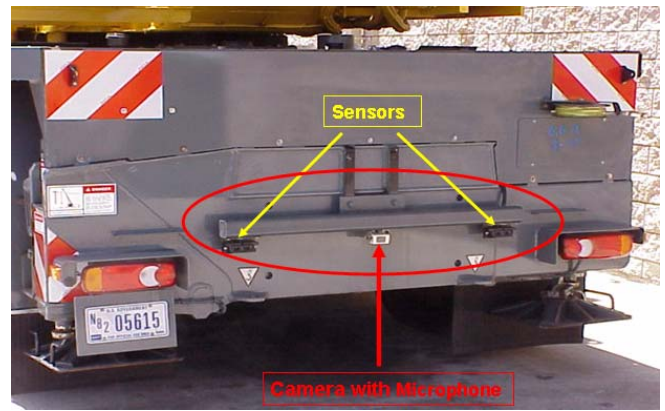
The camera has a built in microphone, can operate in temperature ranges from 22 to 140 degrees Fahrenheit, and has a heater, which prevents the lens area from fogging or icing over. The camera is connected to the LCD screen in the operators cab and allows the operator to see any obstacles in his path. The microphone allows the operator to hear any stop commands from pedestrians.

The ultrasonic sensor admits high frequency sound waves and when these sound waves hit an object, they bounce back to the sensor. The sensor can determine the time elapsed from when it sent the wave to when the wave returned and tell how far away the object is. The sensor installed by NAVFAC Hawaii has six detection zones, 9ft, 5ft, 4ft, 3ft, 2ft, and 1ft. The user can program the unit to alarm in any of these detection zones so if the crane is being used on a busy pier close to several obstacles, the unit could be set to alarm at a closer distance. The sensor has a detection area approximately 9ft across and, depending on the installed orientation, an angle of 15% below centerline and 35% above.

The units installed consist of a camera, monitor, and two ultrasonic sensors. The system can be outfitted with two additional cameras to provide side coverage but the monitor can only view one camera at a time.
