THE CRANE CORNER

Navy Crane Center Technical Bulletin

60th Edition – December 2008

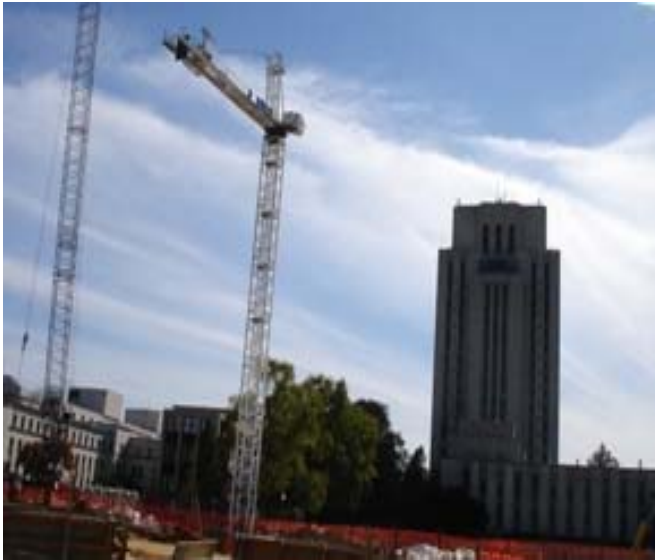
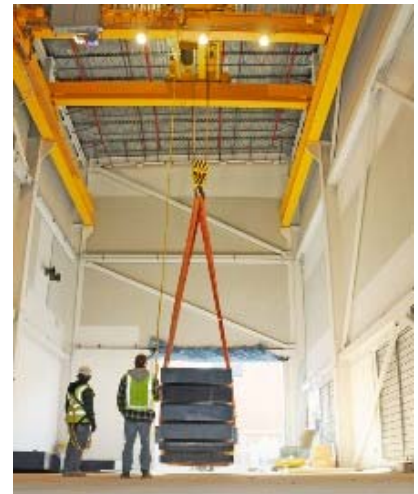
The Navy Crane Center provides a variety of services in support of worldwide Navy construction projects. The following are some of the services provided by Navy Crane Center divisions. Our Design Division and NCCR & Safety/Training Division, as well as the Audio Visual Department of Norfolk Naval Shipyard, were on site at the National Naval Medical Center, Bethesda, Maryland to oversee and photograph erection and testing of a tower crane that will support construction of the Walter Reed National Military Medical Center at Bethesda. Our Quality Assurance Branch ensured the safety of personnel during erection of the crane. Video taken at the site will be used to train personnel on oversight of contractor tower crane erection and operation. Navy Crane Center personnel expect to return to the site to provide quality assurance for erection of two additional tower cranes.

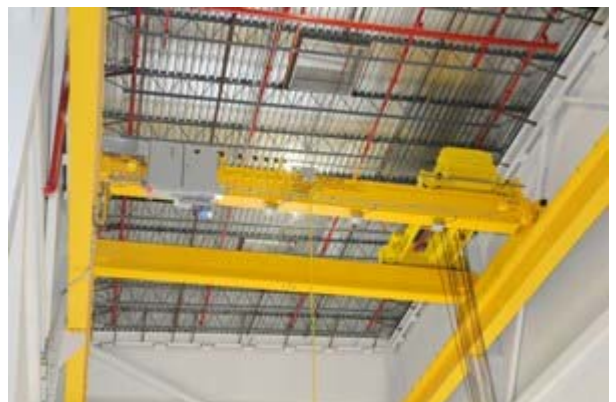
Design Division and Project Management Division personnel were on-site at Naval Air Station, Sigonella, Italy to provide oversight of acceptance testing of a 4.5-metric ton capacity bridge crane. Compliance Division personnel had previously inspected the crane during an audit of the facility. Acceptance testing ensured that identified deficiencies in the runway system were corrected, and that the crane equipment meets UFC 3-320-07N design and NAVFAC P-307 certification requirements.

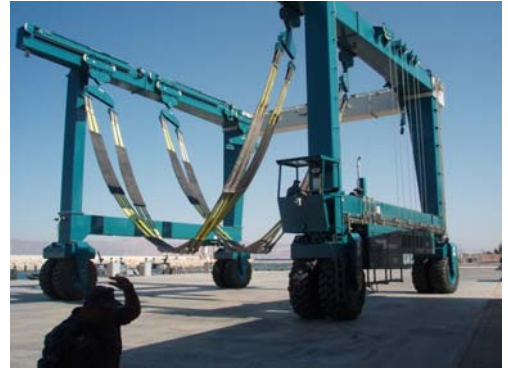
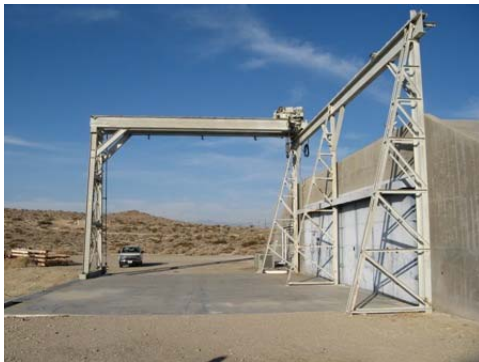
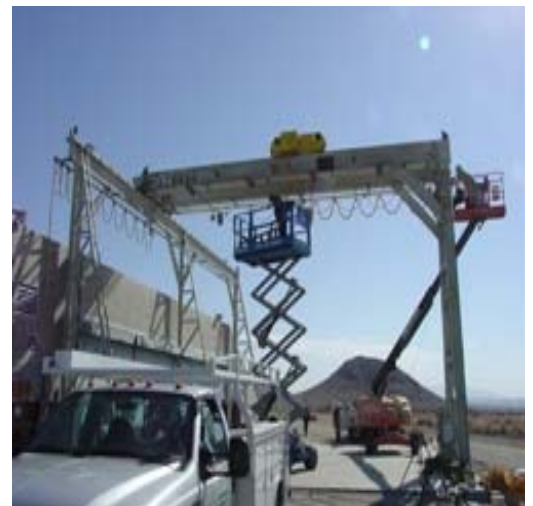
Design Division and In-Service Engineering Division personnel provided oversight of the installation and testing of a 35-ton capacity bridge crane at Fleet Readiness Center, Cherry Point, North Carolina. The on-site team overcame installation challenges and ensured satisfactory load testing by the crane contractor. All shop testing identified deficiencies were corrected and the crane was accepted.

Design Division personnel provided oversight of the installation and testing of a 250-ton capacity mobile boat hoist at Naval Amphibious Base, Little Creek, Virginia. Design Division personnel previously attended shop testing of crane components at the manufacturer's facility.

Design Division personnel provided oversight of acceptance testing following the overhaul of a 20-ton semi-gantry crane located at Naval Air Weapons Station, China Lake, California. The overhaul included replacement of the hoist, travel drive, electrification and crane controls. Quality assurance was performed to ensure contractor compliance with the contract. ■
