# THE CRANE CORNER

## *Navy Crane Center Technical Bulletin*

62nd Edition – June 2009

## OVERLOAD PREVENTION AND USE OF LOAD INDICATING DEVICES

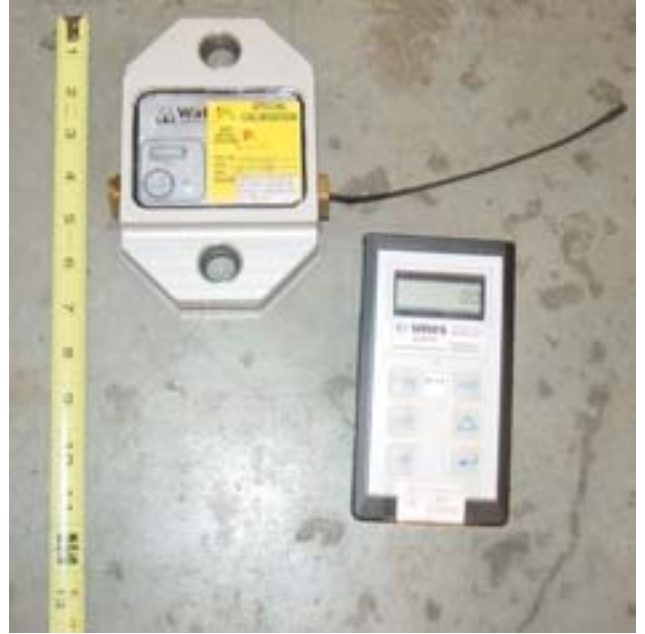
For lifting operations involving constrained loads or lifts that are potentially obstructed, the LID used in combination with a manual hoist will help mitigate the risk of overload. NAVFAC P-307, paragraph 10.5 (Pre-lift Preparation) requires the operator/rigger to know the weight of the load to be lifted and where overloading is possible due to binding conditions, a LID shall be used. When a LID is used, an appropriate stop point shall be established and the LID shall be carefully monitored to ensure the stop point is not exceeded.

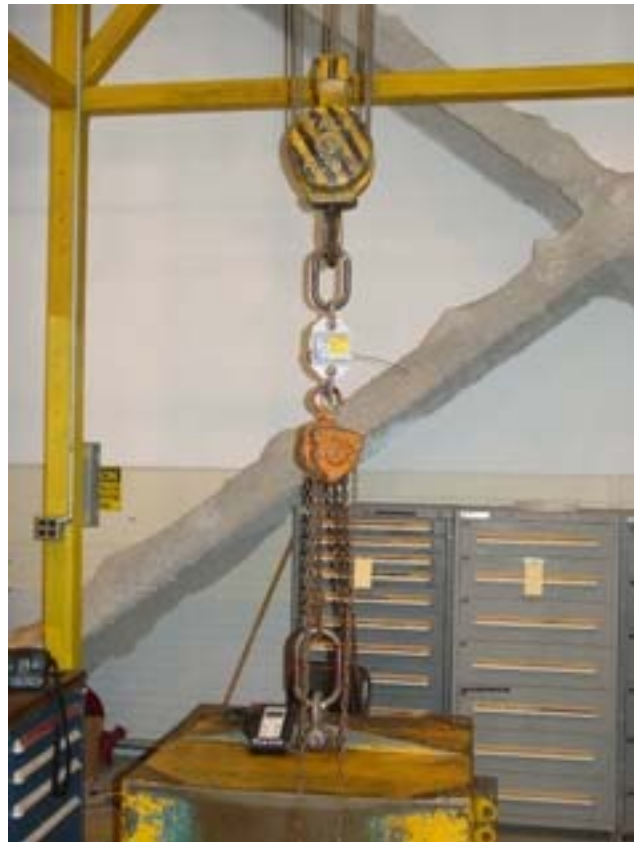
Lifting a load that is suspended and pinned in a horizontal lathe requires more in-depth planning than just a crane and slings. For example, during a crane lift of a rotor from a horizontal lathe, a manual hoist and a LID can be attached to the crane hook. Pre-determined stop points can be established to mitigate the risk of overload to the crane and rigging gear. Once the crane’s hoist block is positioned over the rotor center of gravity, hoisting of the load can be performed “one click at a time” with the manual hoist in lieu of the crane while monitoring the LID for precise movement of the load. As the pre-determined load is reached, the machinist, upon visual observation of the rotor can release the rotor from the lathe and the load will maintain its present attitude on the crane. This is one example of change that can be instrumental to further reduce crane and rigging accidents throughout shore based Navy activities.

LIDs available for purchase today are smaller in size, weigh less, and have greater working load capacities making it easy for category 2 and 3 crane operators to use an LID in everyday operations. The digital LID with hand held display can be placed in the operator/rigger tool bag and carried from job to job. ■
